City of Goldsboro
Historic District
Commission
June 03, 2025

AGENDA
HISTORIC DISTRICT COMMISSION
City of Goldsboro
Tuesday, June 03, 2025, 5:30 P.M.

Sanctuary Building Brick Masonry Investigation Report

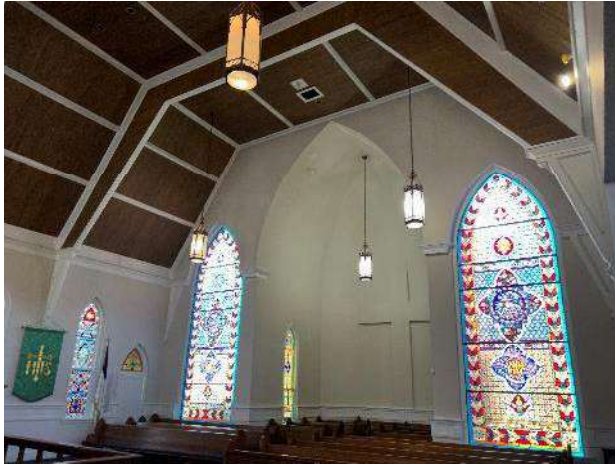
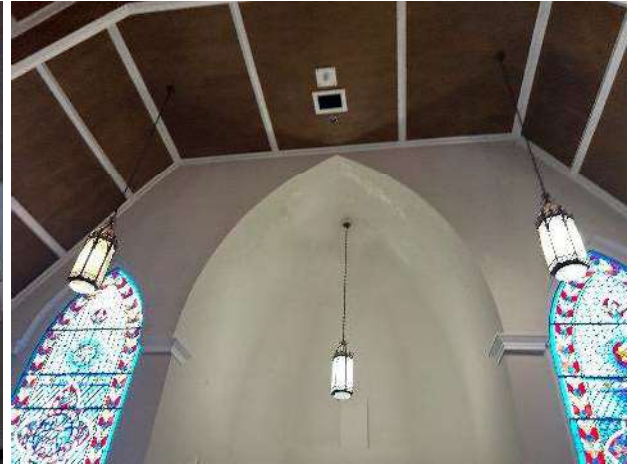
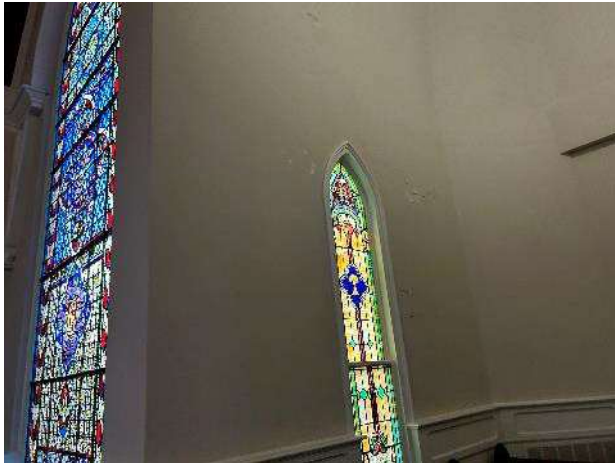
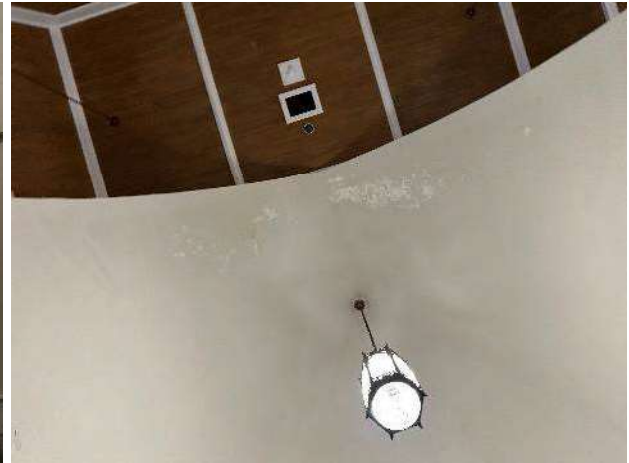
- Discoloration and peeling plaster began near the top of the multi-story archway along the east elevation of the sanctuary. Discoloration of the plaster continued down below the arch along each side. Along the exterior, this location consists of a roof-to-wall transition with step flashing visible from the ground. Moisture readings of the plaster were performed with a scan-type moisture meter: readings up to 55.0% were detected indicating that the paint and plaster likely retain elevated levels of moisture content.

Damaged Archway

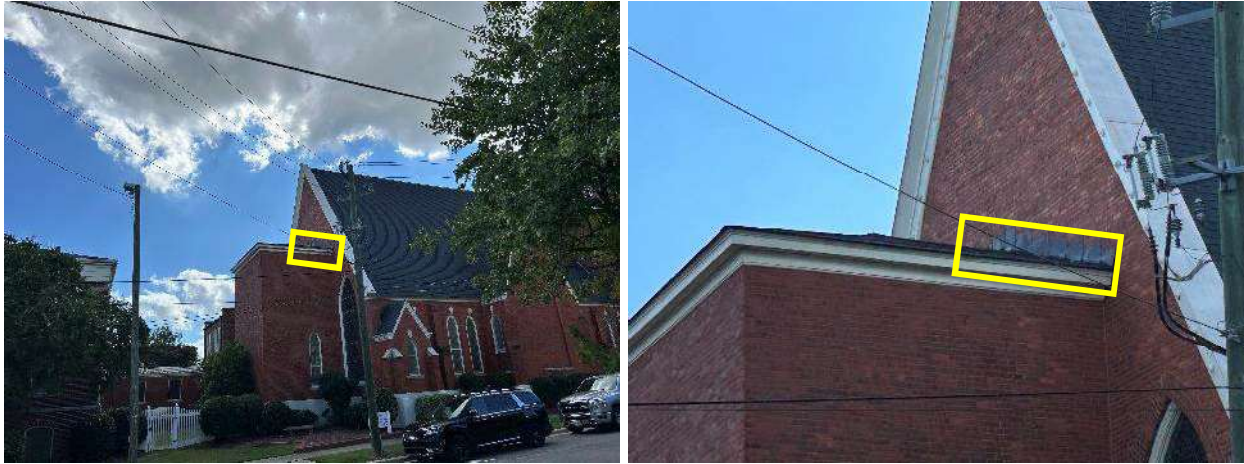
Roof-to-Wall Transition

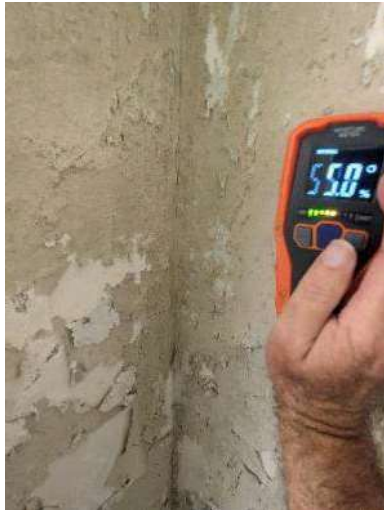
Elevated Moisture Reading Along Interior Side of Plaster.

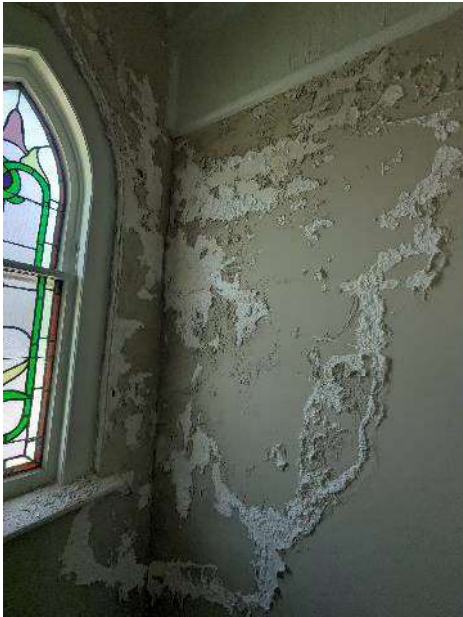
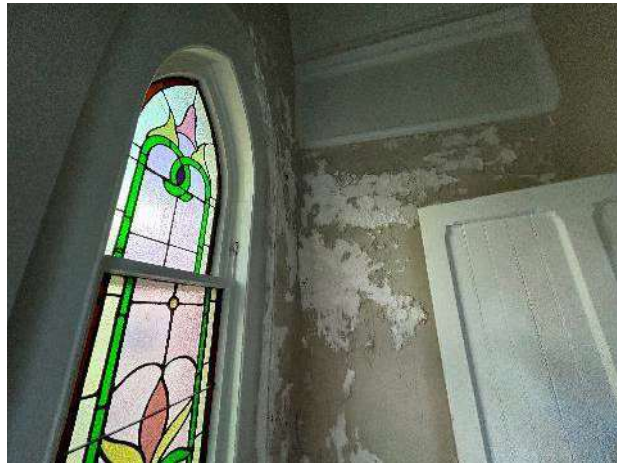
- Discoloration, deteriorated plaster and peeling paint was present at the small exit door located at the northeast corner of the sanctuary. A roof-to-wall transition is present at the lower gable roof with step flashing. In this location, the buttress/pilaster extends outward from the wall near the bottom of the gable. This creates an area where water can collect and infiltrate the roof-to-wall transition in wind-driven rain events. The location where the pilaster jogs and an internal gutter is present is where the water damage is visible at the interior.

Damaged Plaster/Paint

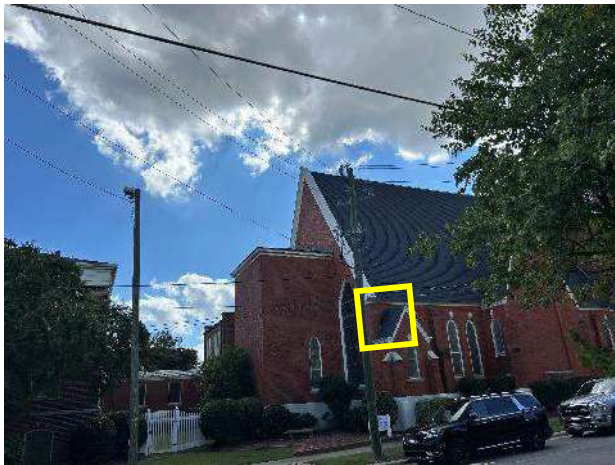
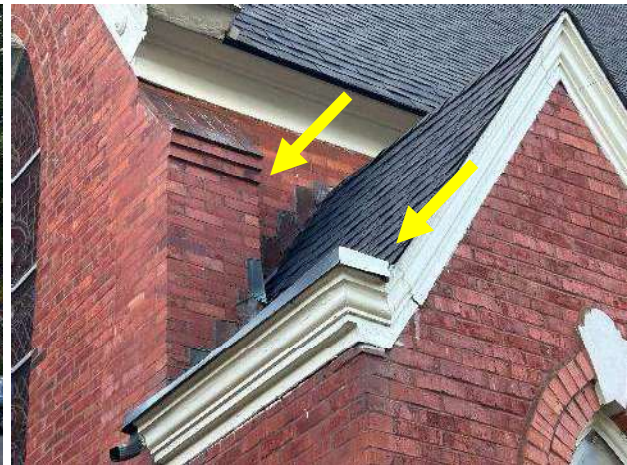
Pilaster Extends Beyond Wall Damming Water at Corner, Internal Gutter is Present

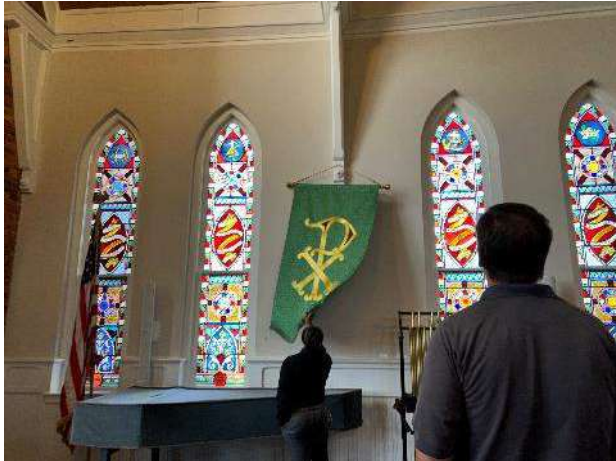
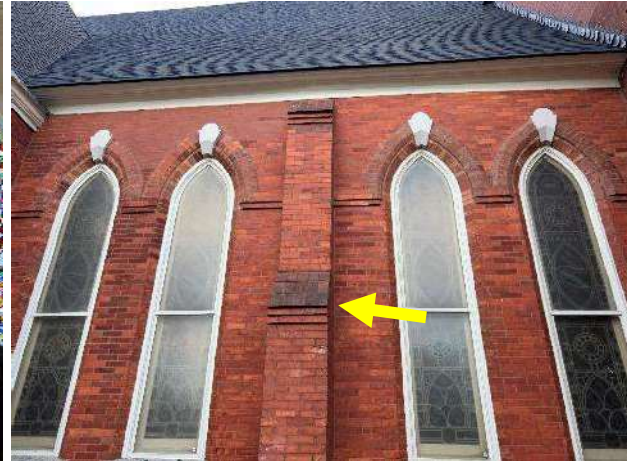
- Along the left-hand side (LHS) of the chancel (north elevation), damaged plaster and peeling paint was observed behind a banner hanging on the wall. Along the exterior of this location, a brick pilaster/buttness is constructed between window units. Moisture readings of the plaster were performed with a scan-type moisture meter: readings ranged from 82.5% and more [over-limit ("OL")] were detected.

Interior Leakage Centered on Pilaster

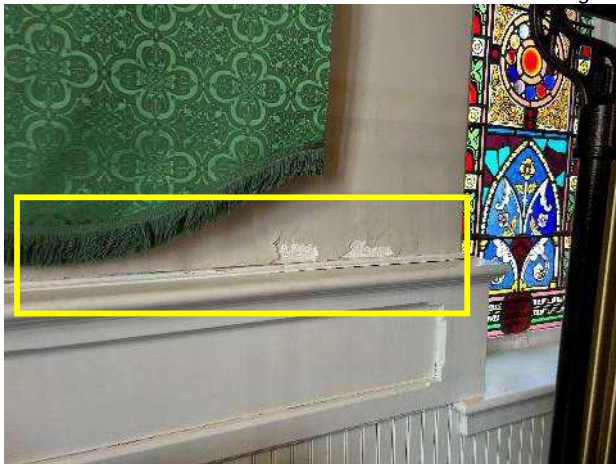
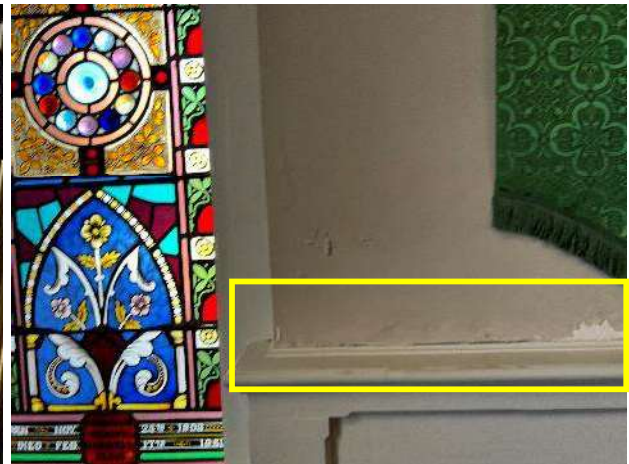
Water Damage at Transition to Paneling

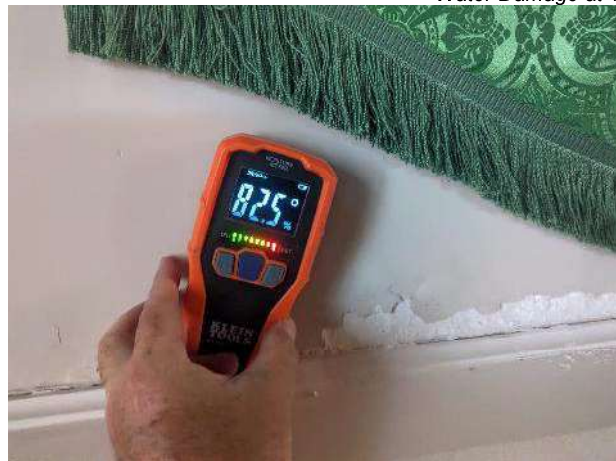
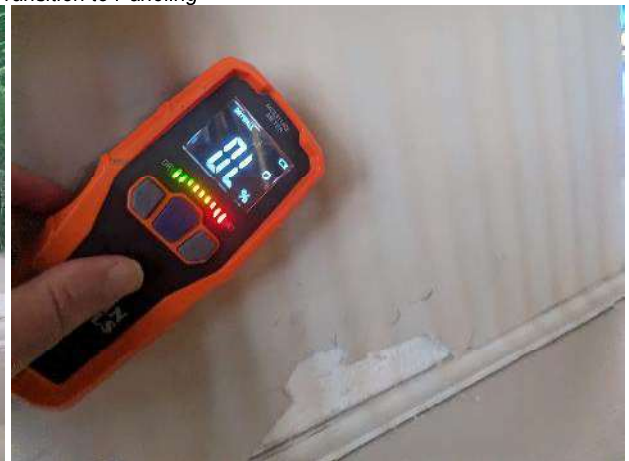
Elevated moisture readings in paint and plaster

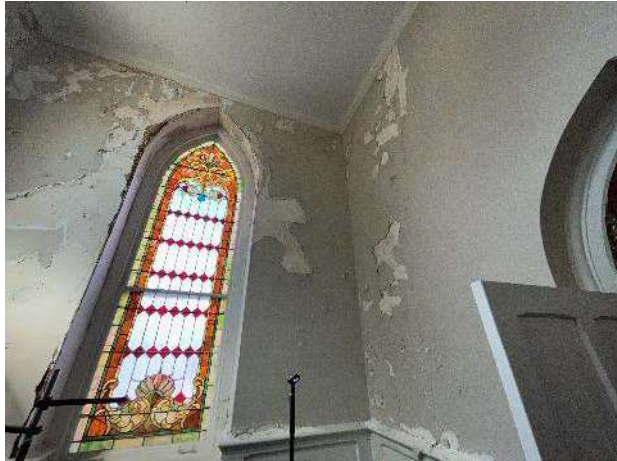
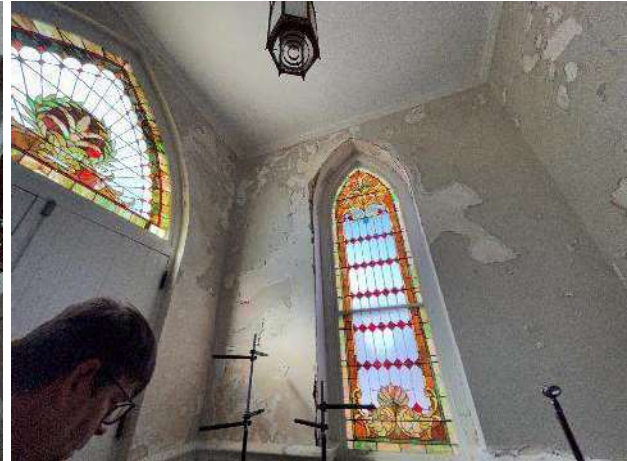
- In the tower along the northwest corner of the sanctuary, paint and plaster were significantly deteriorated along the entirety of the north, and portions of the east and west elevation at the first-floor level. Multiple moisture readings of the wall from 55.8% up to OL readings indicated that significant moisture levels are present in the paint / plaster at the northwest tower exterior walls.

Damaged Paint and Plaster Throughout

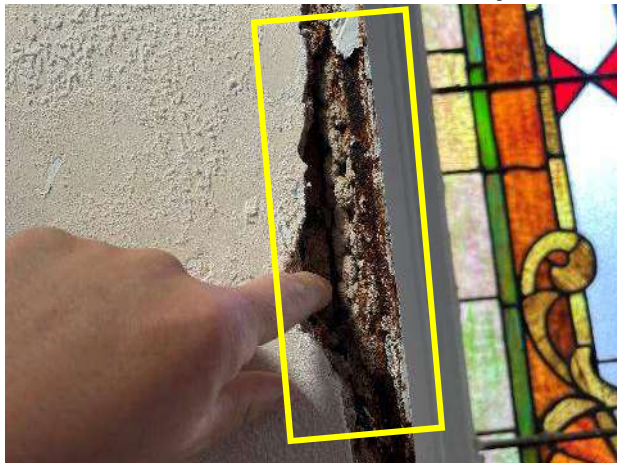
Damaged Plaster at the Corner

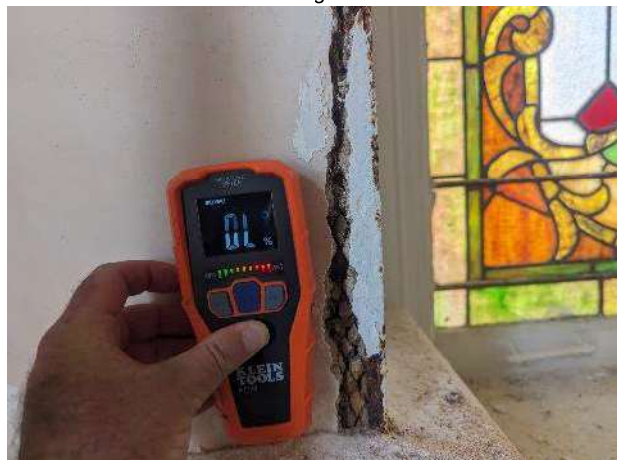
Elevated Moisture Reading

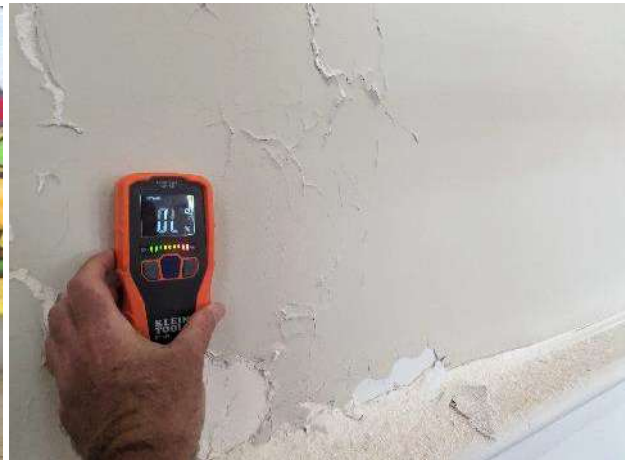
Elevated Moisture Reading

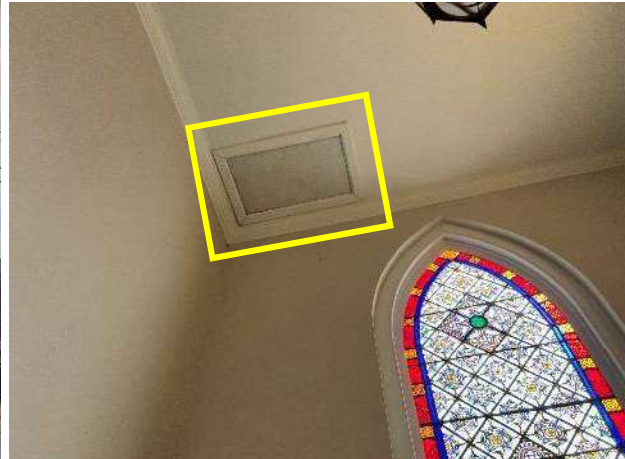
- In the shorter tower along the southwest corner of the sanctuary, minor paint and plaster damage were noted along the south and east elevation at the first floor. Moisture readings of the plaster were performed with a scan-type moisture meter: readings from 27.4% to over-limit (“OL”) were detected indicating that portions of the paint and plaster retain elevated levels of moisture content.

Water Staining on Attic Hatch

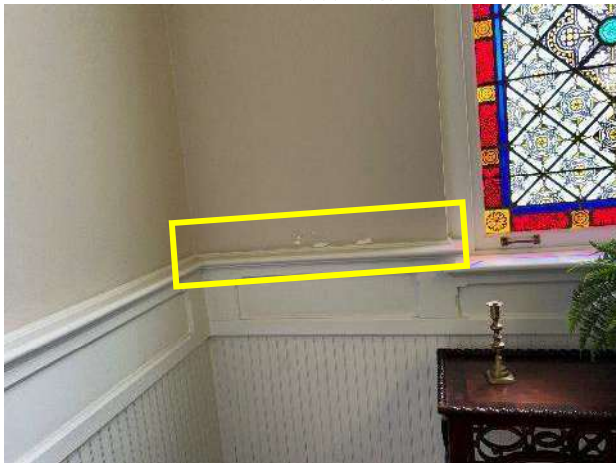
Water Staining/Damage at Paint/Plaster at Transition to Paneling

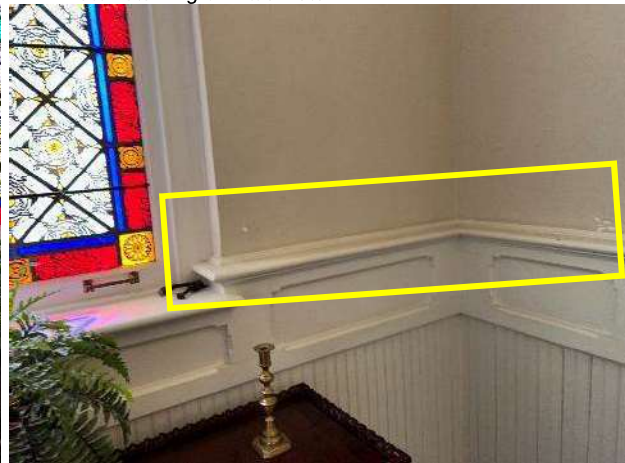
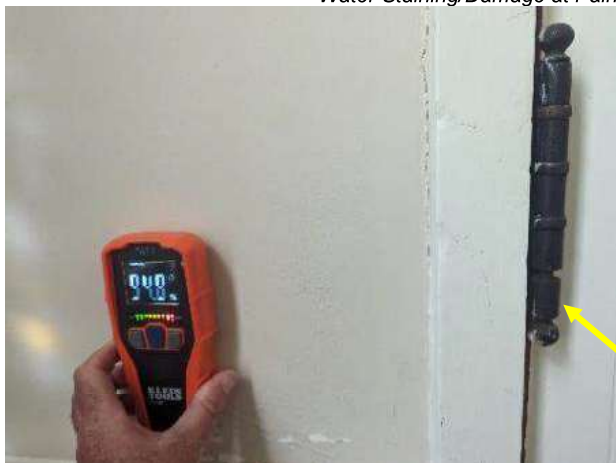
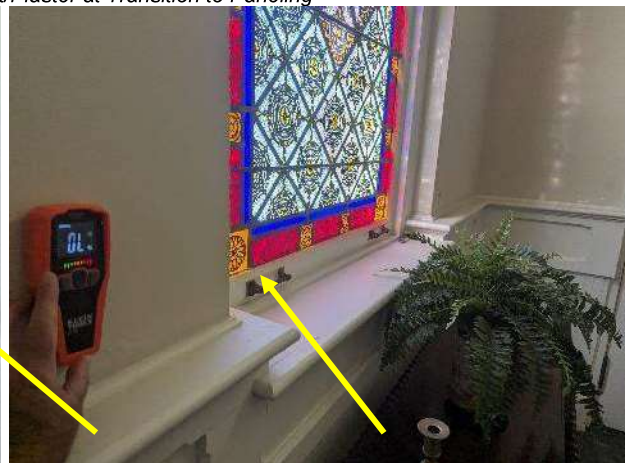
Elevated Moisture Content Adjacent Door & Adjacent Window

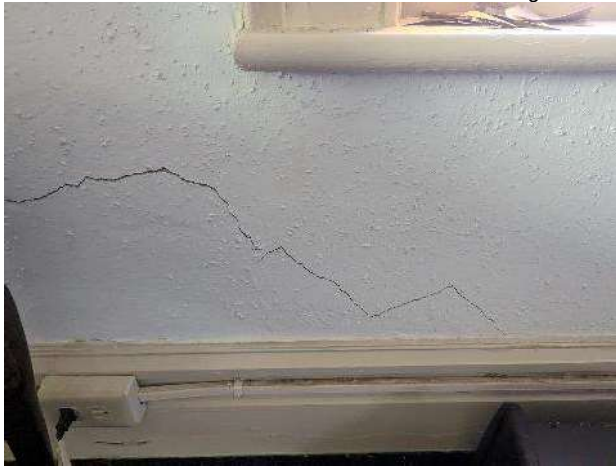
- In the southernmost section along the west elevation of the second-floor level of the sanctuary, paint delamination at trim and plaster damage (cracks) were noted along the west elevation typically at the base of the wall under the level of the windowsills. No elevated levels of moisture were detected. Delamination and/or damage was noted at wood trim at perimeters of windows and adjacent the window heads.

Cracked Plaster Typically Underneath Windows

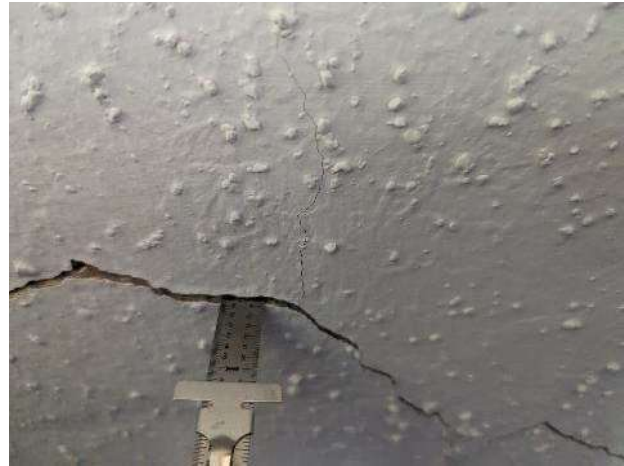
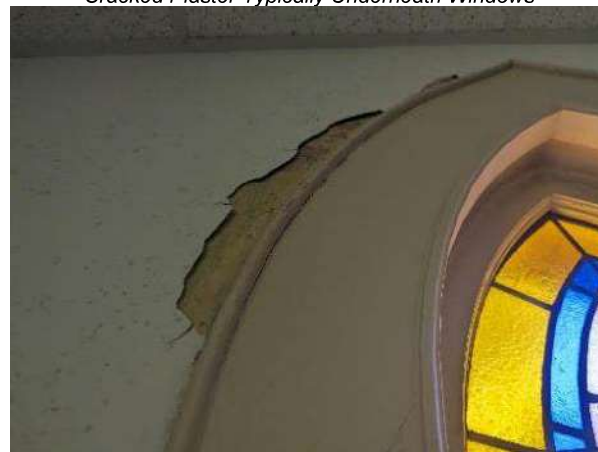
Damaged Finishes Adjacent Window Head

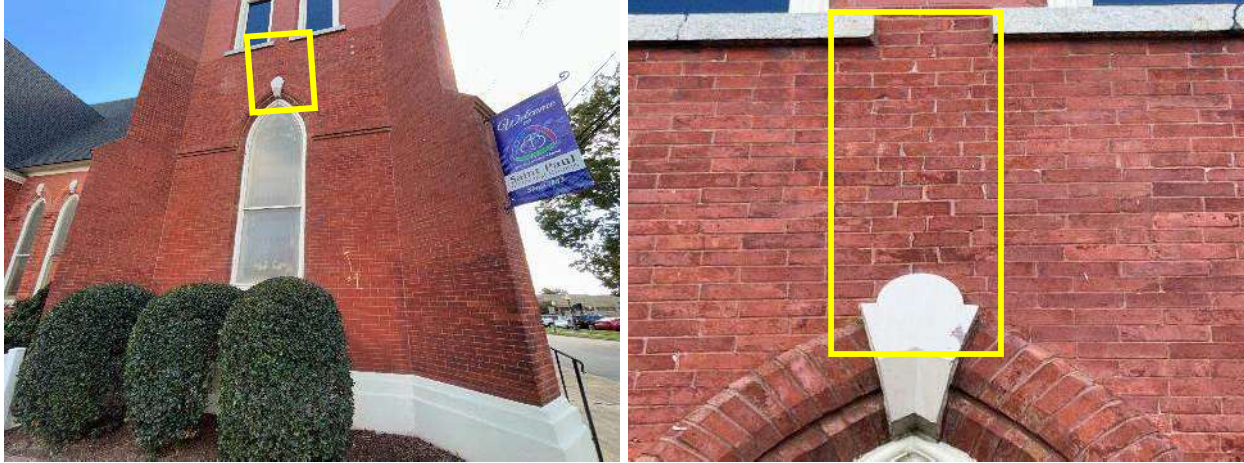
- A large vertical crack is present in the mortar and brick at the top of the arched window along the north elevation of the northwest tower.

Crack Along North Elevation of Tower

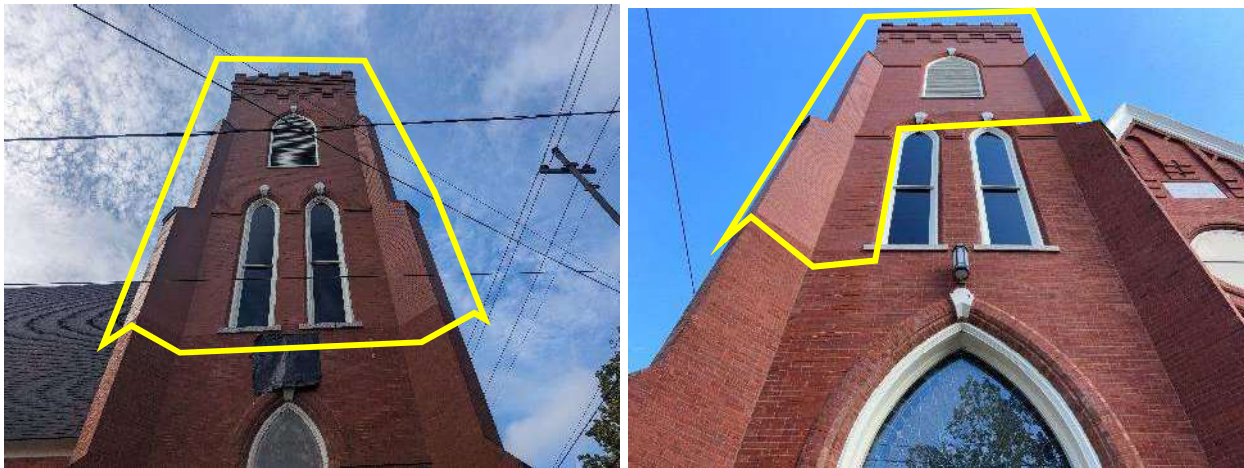
- A significant portion of the multi-wythe masonry at the northwest tower appears to have been replaced due to previous damage at some point in the past. The original mortar appears to be in poor condition; however, the mortar used to construct the replacement area appears to be satisfactory. It is likely that lime-sand mortar was utilized to originally construct the Sanctuary. It is believed that the area of brick replaced was possibly constructed with a mortar utilizing Portland cement in lieu of lime-sand.

New Brick (Highlighted) Installed Above Old Brick at North (Left) and West (Right) Elevation

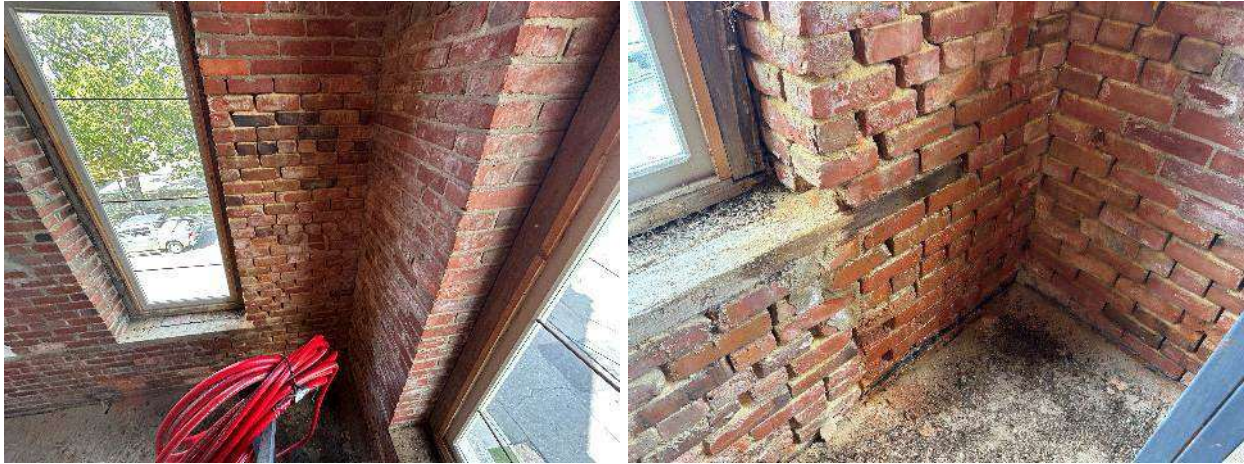
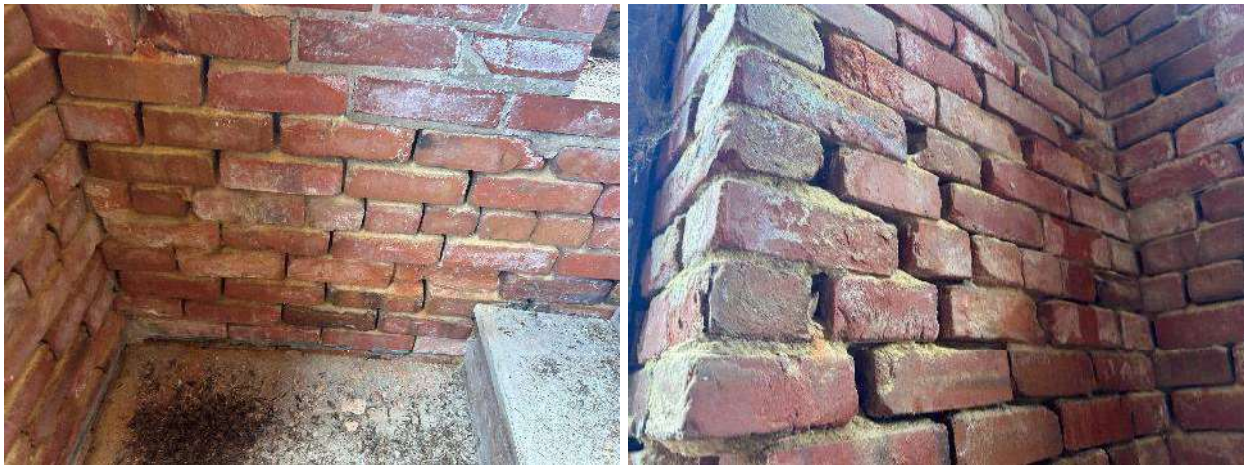
- At the interior of the northwest tower above the finished room, severe deterioration and “wash-out” of original mortar has occurred. The existing mortar has a sand-like feel, appearance and texture. In addition, the original mortar can be easily removed from the wall. This represents a potential structural and safety concern.

Significant Mortar Deterioration

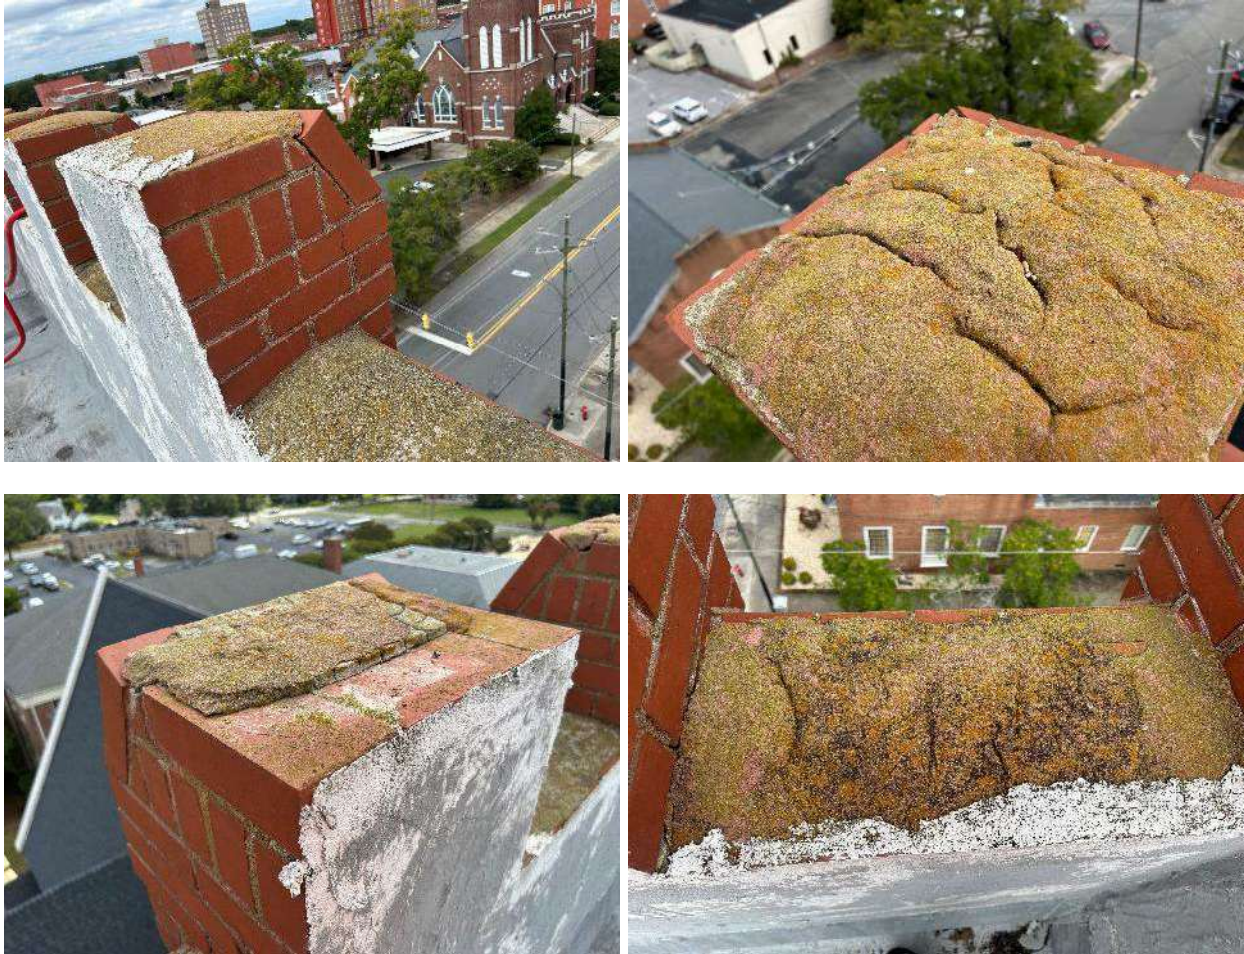
- The battlement parapet of the towers does not incorporate a flashing system to protect upper horizontal surfaces of the masonry. The parge coat / mortar installed at these locations is deteriorated and likely allows water to enter the wall system.

Deteriorated Mortar on Battlement

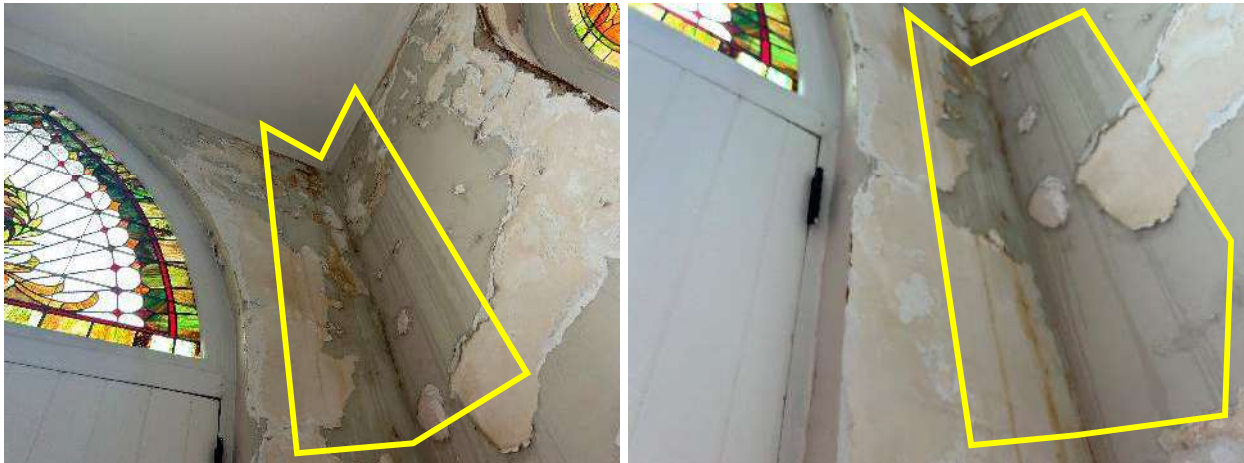
- Streaming down the wall in the room with the damaged plaster. The water appeared to be coming from above the ceiling, however, it is also possible that the water was intruding through the windows in addition.

Water Streaming Down Wall Below Area Where Exterior Spray Rack Installed

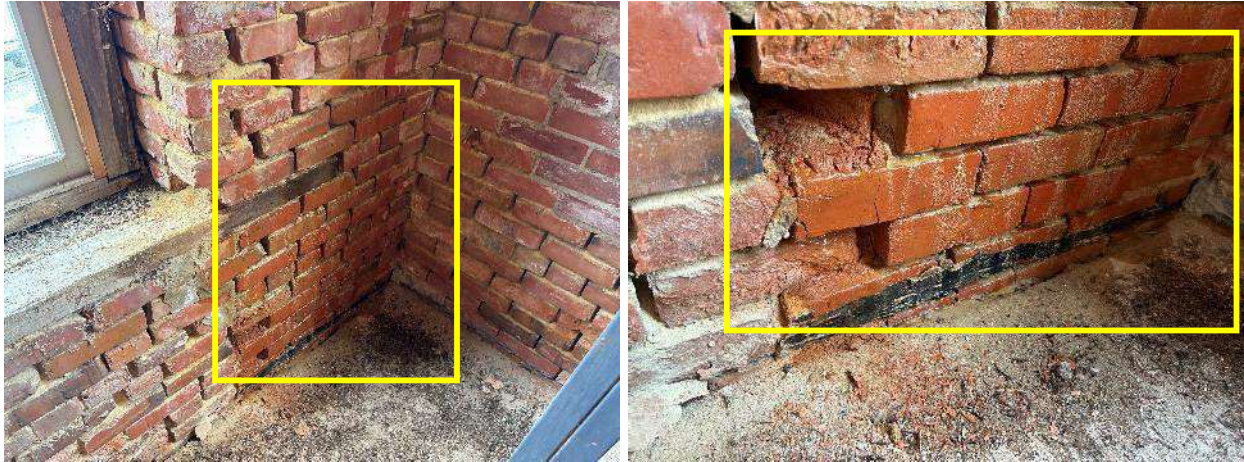
- Through the severely deteriorated mortar just above the ceiling at the next “floor” of the tower. A large amount of water was noted to be running out of the mortar joints at the northwestern corner of the tower. Water was also pooling on the sills of both of the windows adjacent to this location.

Water Leaking Through Deteriorated Mortar

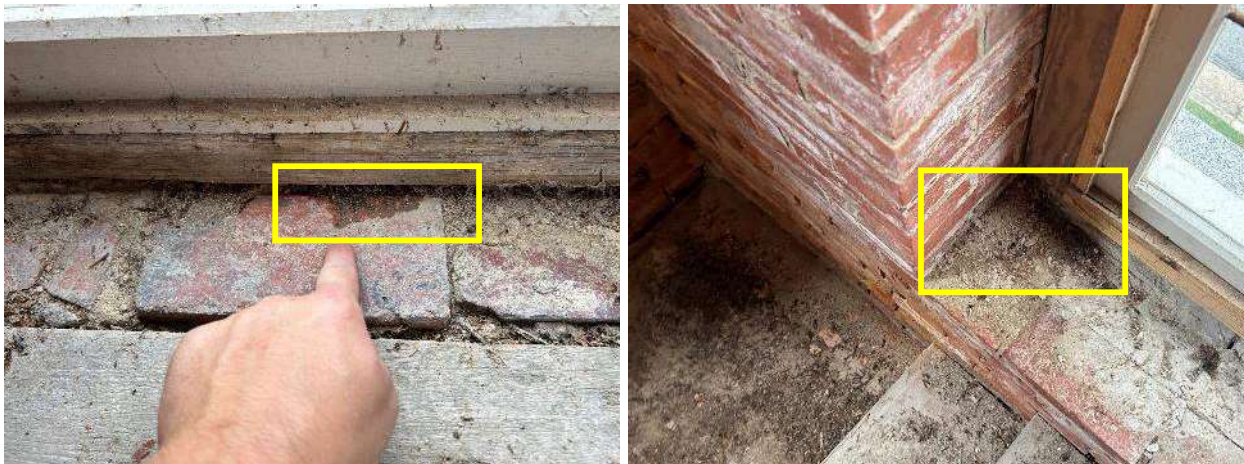
Water Pooling on West Sill (Left) and North Sill (Right)

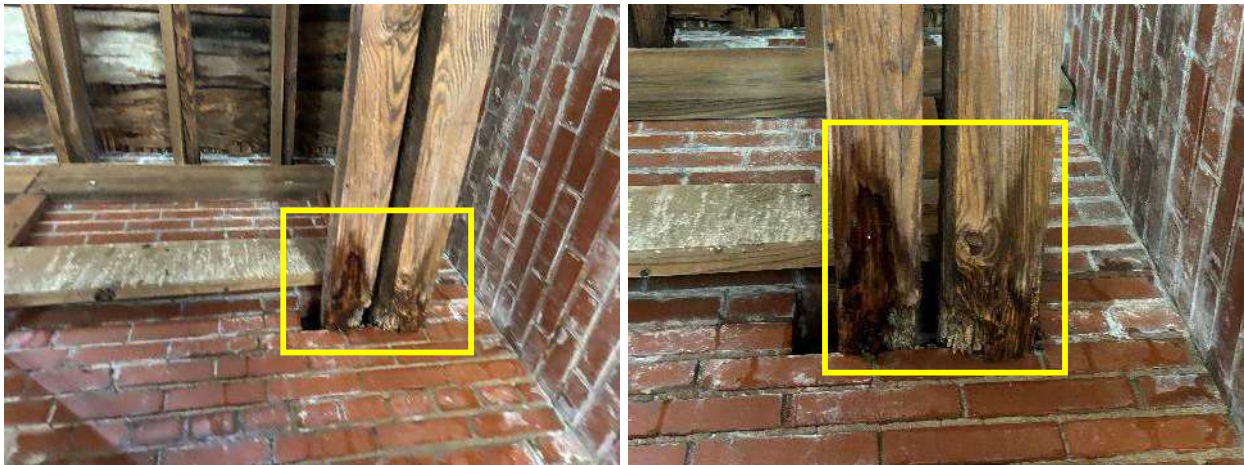
- Significant water intrusion was noted through the beams installed approximately 5-foot below the roofline at the northwestern corner of the tower. Water was running down the wall at this previously repaired area and was noted to be soaking the beams. Additionally, the beams appear to have water damage on, and adjacent to, the wall. Noticeable section loss/rot was observed at this location.

Wet, Deteriorated Wood Beams Set in Brick Masonry Beam Pockets

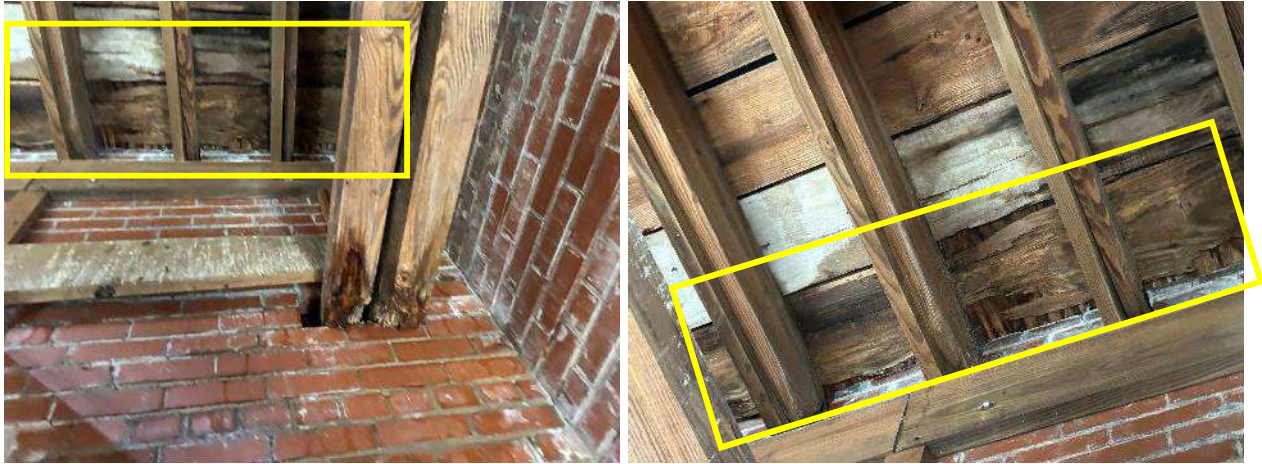
- The underside of the roof deck at the area that was being sprayed appeared to be wet. The wood decking boards, and support beams appeared to be deteriorated at this location, with the board adjacent to the wall having significant section loss.

Significantly Deteriorated Wood Roof Decking Above Leakage Location

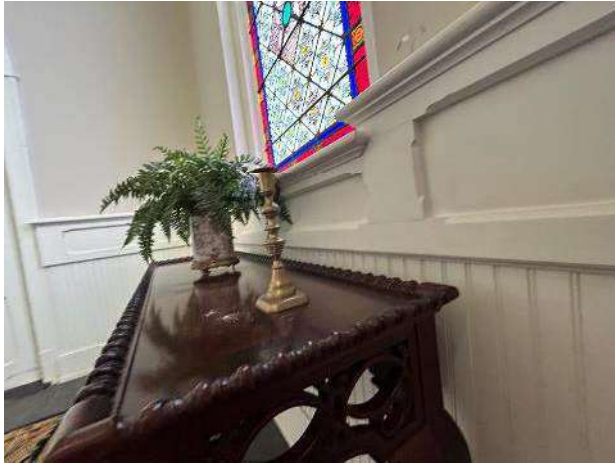
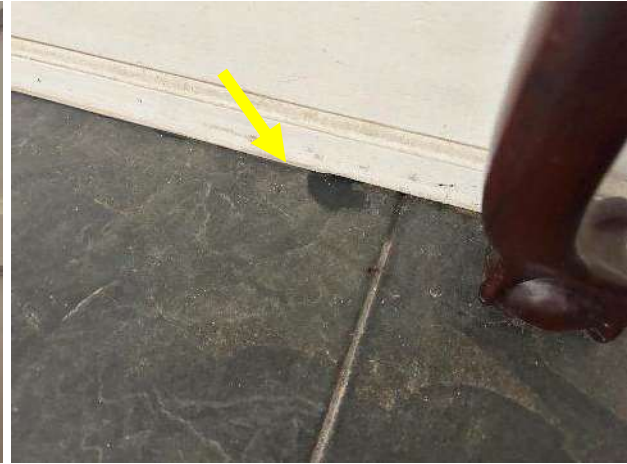
The test was planned to be run for 1.5-hours, however, after approximately 1-hour, water intrusion was noted at the tile floors at the interior of the tower in several locations. In one location, the water was running down the face of the paneling above. Other locations did not exhibit visible water on the wall. It appears that water is collecting and being stored in the mass masonry until it collects along the base of the wall.

Water Infiltration Noted at Two (2) Locations Below Window Area

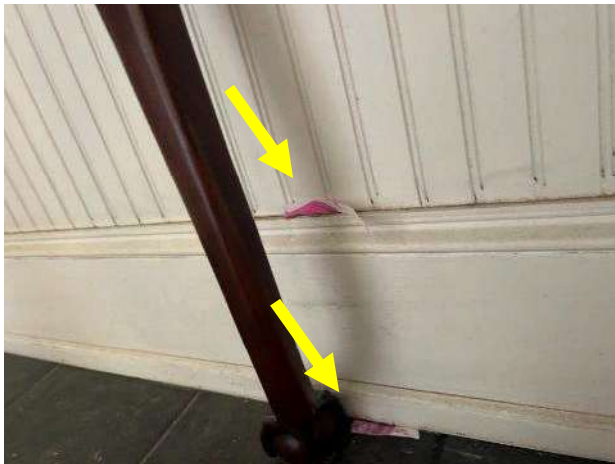
Water Infiltration along Interior of Paneling

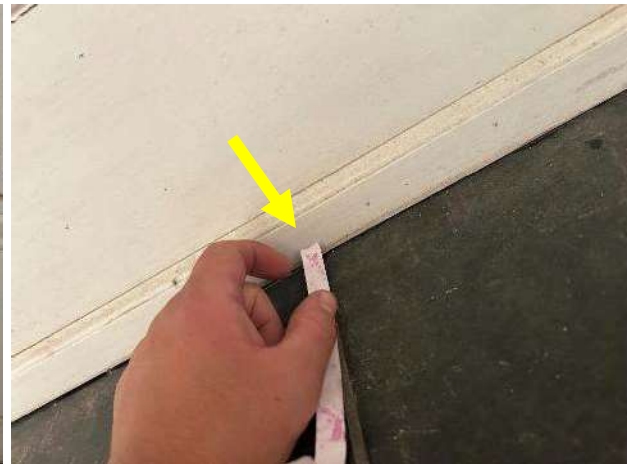
Water Detection Paper (Pink Color) Identifying Water Infiltration

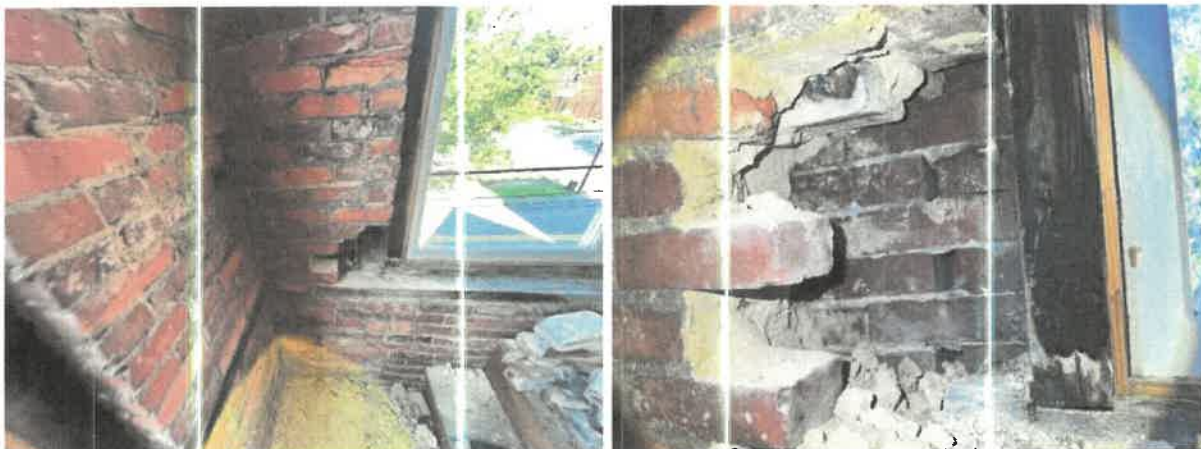
- Neither header nor skewed header courses were observed at: the five (5) courses of brick removed or the single courses above and below excavation, seven (7) courses with no visible attachment to exterior pressed brick.

- A 1-1/4 inch gap or space is present between middle modular wythe and exterior pressed brick wythe. It appears that skewed header courses were only installed where the brick masonry wythes align (which is not often). Gap appears to be area where the exterior wythe is separating from the middle wythe.

No Skewed Header or Visible Attachment Between Brick Units

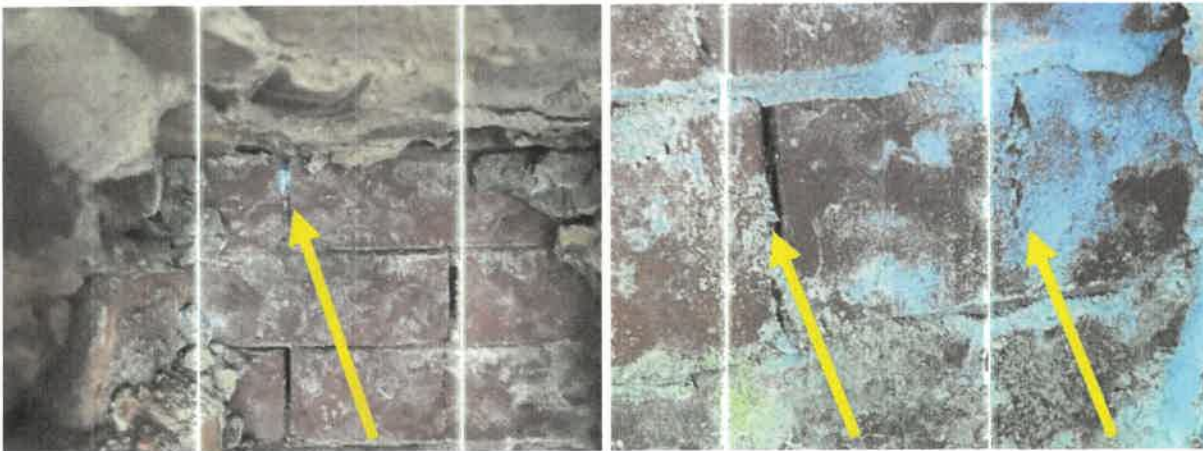
- Exterior wythe head joints were not filled solid. Mortar missing throughout. Daylight is visible at several mortar joints at multiple locations.

Daylight Visible Through Exterior Mortar

Missing Head Joint Mortar, Cracked Brick
