MINUTES OF THE MEETING OF THE
GOLDSBORO HISTORIC DISTRICT COMMISSION
JUNE 3, 2025

Sanctuary Building Brick Masonry Investigation Report

Saint Paul Methodist Church
204 East Chestnut Street
Goldensboro, North Carolina 27530

SKA Project No. 230217.0

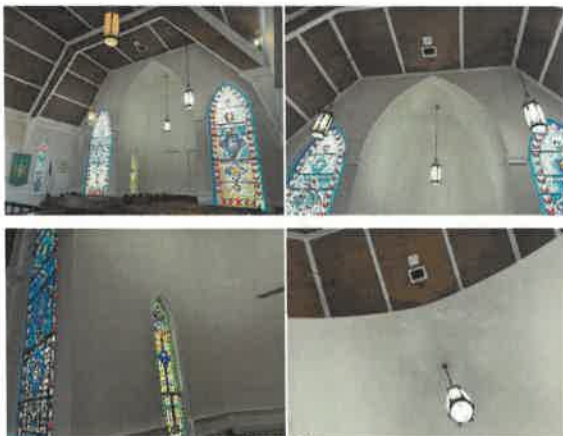
- Discoloration and peeling plaster began near the top of the multi-story archway along the east elevation of the sanctuary. Discoloration of the plaster continued down below the arch along each side. Along the exterior, this location consists of a roof-to-wall transition with step flashing visible from the ground. Moisture readings of the plaster were performed with a scan-type moisture meter. Readings up to 55.0% were detected indicating that the paint and plaster likely retain elevated levels of moisture content.

Damaged Archway

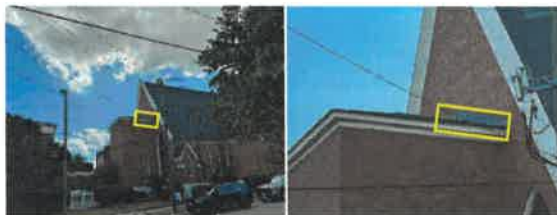
Roof-to-Wall Transition

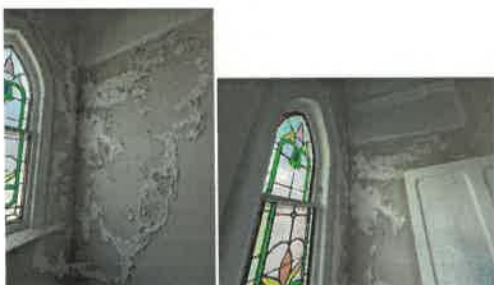
- Discoloration, deteriorated plaster and peeling paint was present at the small exit door located at the northeast corner of the sanctuary. A roof-to-wall transition is present at the lower gable roof with step flashing. In this location, the buttress/plaster extends outward from the wall near the bottom of the gable. This creates an area where water can collect and infiltrate the roof-to-wall transition in wind-driven rain events. The location where the plaster jogs and an internal gutter is present is where the water damage is visible at the interior.

Damaged Plaster/Paint

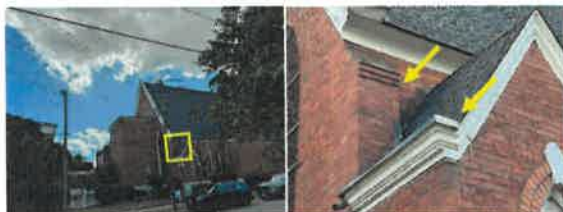
Plaster Extends Beyond Wall Causing Water at Corner, Internal Gutter is Present

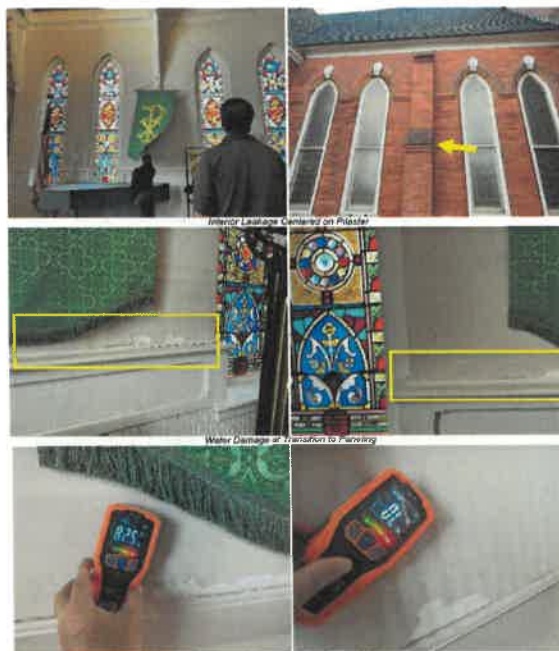
- Along the left-hand side (LHS) of the chancel (north elevation), damaged plaster and peeling paint was observed behind a banner hanging on the wall. Along the exterior of this location, a brick pilaster/butress is constructed between window units. Moisture readings of the plaster were performed with a scan-type moisture meter: readings ranged from 82.5% and more [over-limit ("OL")] were detected.

Interior Damage Caused by Plaster

Water Damage at Transition to Parvise

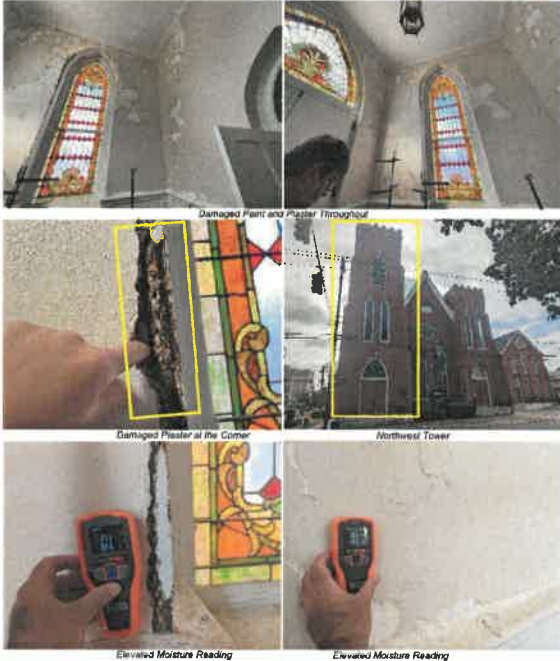
- In the tower along the northwest corner of the sanctuary, paint and plaster were significantly deteriorated along the entirety of the north, and portions of the east and west elevation at the first-floor level. Multiple moisture readings of the wall from 55.8% up to OL readings indicated that significant moisture levels are present in the paint / plaster at the northwest tower exterior walls,

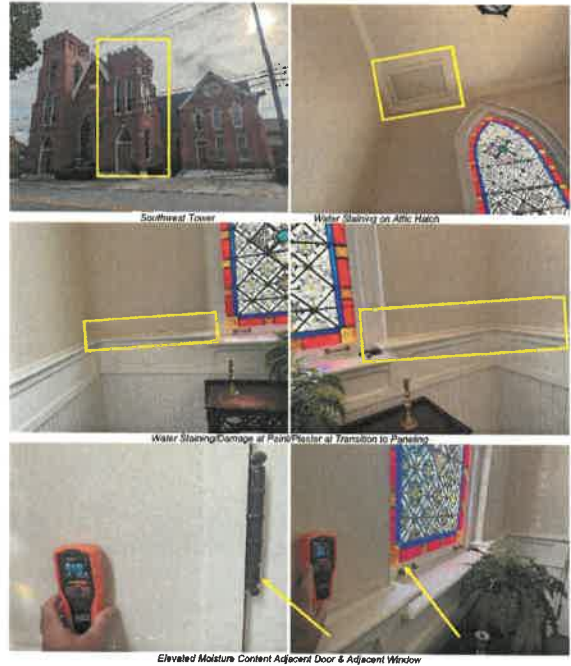
- In the shorter tower along the southwest corner of the sanctuary, minor paint and plaster damage were noted along the south and east elevation at the first floor. Moisture readings of the plaster were performed with a scan-type moisture meter; readings from 27.4% to over-limit ("OL") were detected indicating that portions of the paint and plaster retain elevated levels of moisture content.

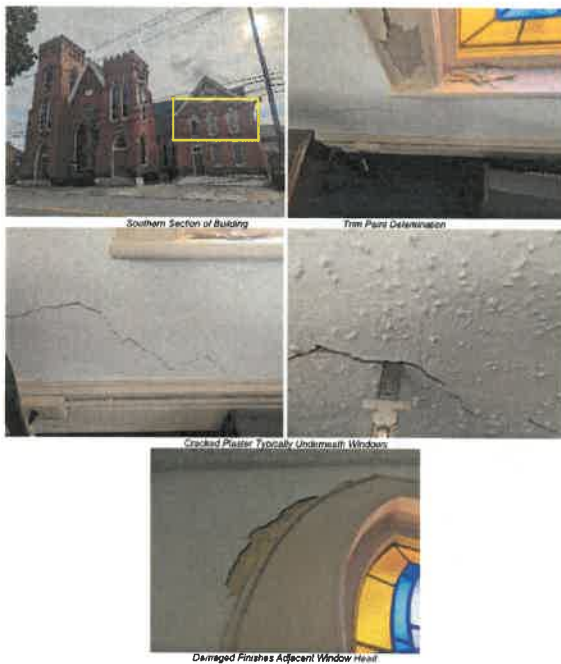
- In the southernmost section along the west elevation of the second-floor level of the sanctuary, paint delamination at trim and plaster damage (cracks) were noted along the west elevation typically at the base of the wall under the level of the windowsills. No elevated levels of moisture were detected. Delamination and/or damage was noted at wood trim at perimeters of windows and adjacent the window heads.

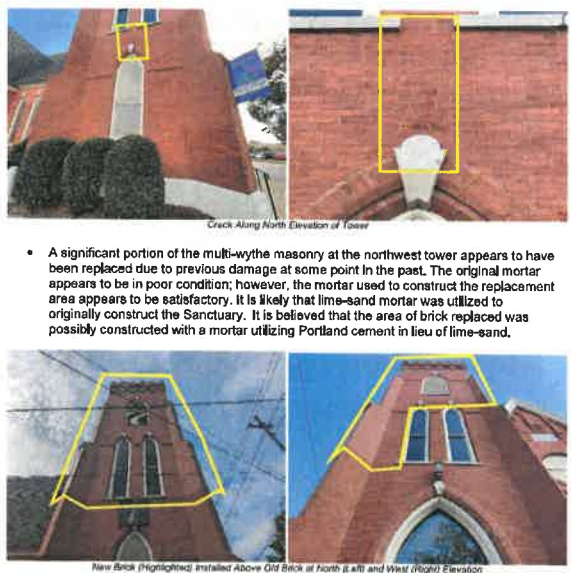
- A large vertical crack is present in the mortar and brick at the top of the arched window along the north elevation of the northwest tower.

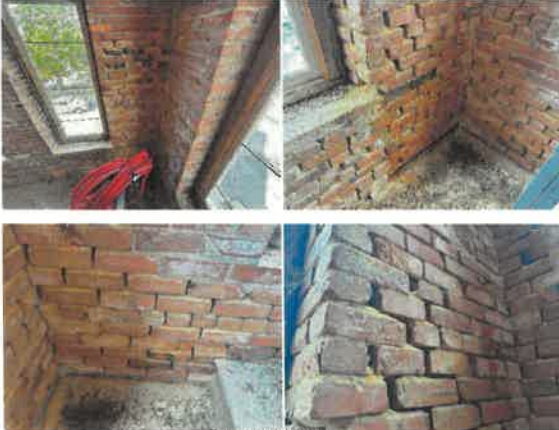
- At the interior of the northwest tower above the finished room, severe deterioration and "wash-out" of original mortar has occurred. The existing mortar has a sand-like feel, appearance and texture. In addition, the original mortar can be easily removed from the wall. This represents a potential structural and safety concern.

Significant Mortar Deterioration

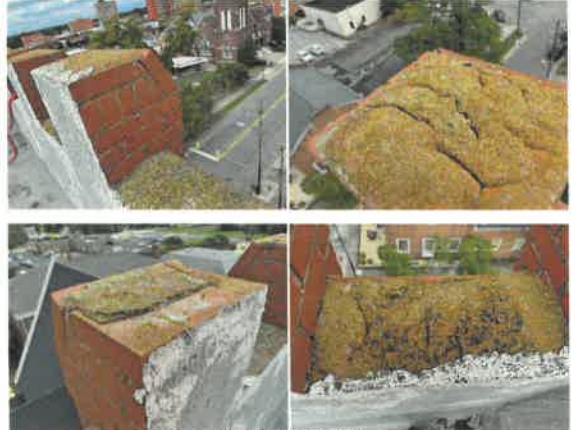
- The battlement parapet of the towers does not incorporate a flashing system to protect upper horizontal surfaces of the masonry. The parge coat / mortar installed at these locations is deteriorated and likely allows water to enter the wall system.

Deteriorated Mortar on Battlement

- 5) At all parapets, a new flashing system should be installed to prevent water from infiltrating the top surface of the parapet. In addition, an interior rainscreen cladding can be installed (where allowed) to further prevent water from penetrating the multi-wythe masonry. This system allows breathability of the interior sides of the masonry walls while also allowing proper integration of existing and future roof installations.

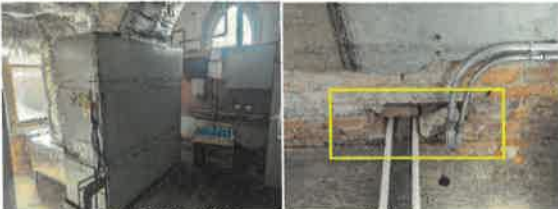
- At the east elevation second floor mechanical room, large gaps in the brick masonry are present. The gaps in the masonry appear to be old or abandoned mechanical penetrations where the brick masonry was not subsequently restored. Two (2) mechanical units located in this area appear to be more recent installations. However, penetrations through the brick masonry do not appear to be properly sealed.

Second Floor Mechanical Room

Unsealed Penetrations

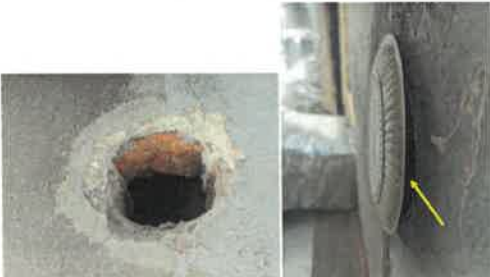
Abandoned Penetrations of Brick Masonry Wall

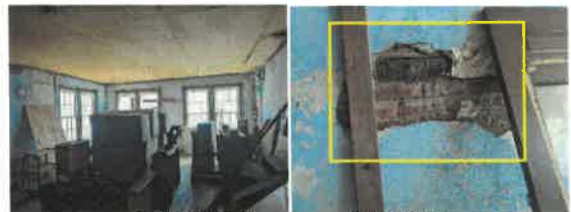
- At the east elevation second floor storage rooms (adjacent to the mechanical room), gaps in the brick masonry are present. This is likely from mechanical components that have been removed. In addition, plaster delamination is present adjacent to these areas.

Second Floor storage room

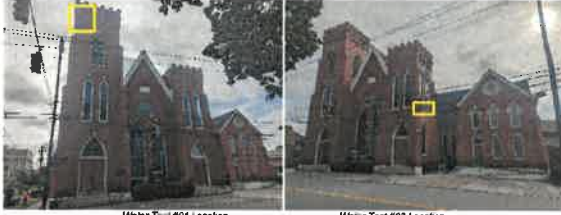
Water Test #01 (WT#01) – Northwest Tower, West Elevation

Two (2) locations were selected to be tested. The first location was selected to be the taller, northwest tower. Water was applied to the western face near the north corner of the tower just below the battlement parapet. The second location was at the shorter, southwest tower. Water was applied to the south elevation just below the sill of the second floor windows.

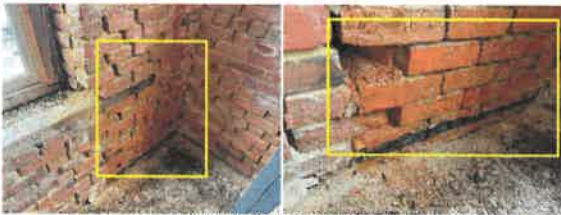
- Through the severely deteriorated mortar just above the ceiling at the next "floor" of the tower, A large amount of water was noted to be running out of the mortar joints at the northwestern corner of the tower. Water was also pooling on the sills of both of the windows adjacent to this location.

Water Leaking Through Deteriorated Mortar

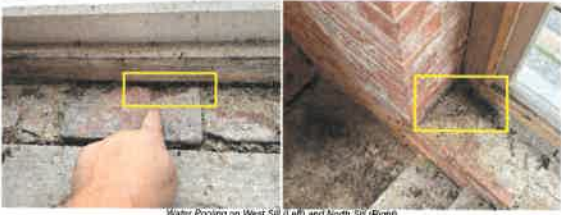
Water Pooling on West Sill (Left) and North Sill (Right)

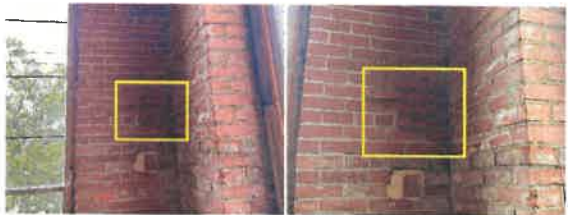
- A portion of the brick and mortar was repaired at the midpoint of the window, approximately 5-foot above the previously outlined location. This indicates that water infiltration is not limited to the original installed masonry walls.

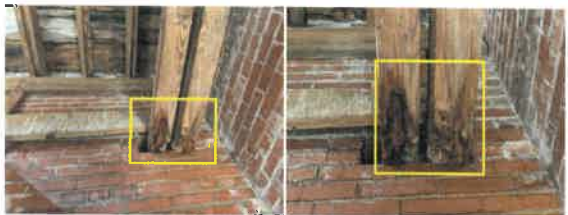
- Significant water intrusion was noted through the beams installed approximately 5-foot below the roofline at the northwestern corner of the tower. Water was running down the wall at this previously repaired area and was noted to be soaking the beams. Additionally, the beams appear to have water damage on, and adjacent to, the wall. Noticeable section loss/rot was observed at this location.

Wet, Deteriorated Wood Beams Set in Brick Masonry Beam Pockets

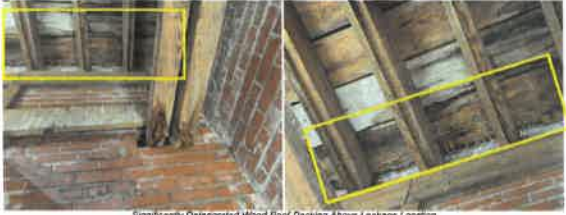
- The underside of the roof deck at the area that was being sprayed appeared to be wet. The wood decking boards, and support beams appeared to be deteriorated at this location, with the board adjacent to the wall having significant section loss.

Significantly Deteriorated Wood Floor Decking Above Leakage Location

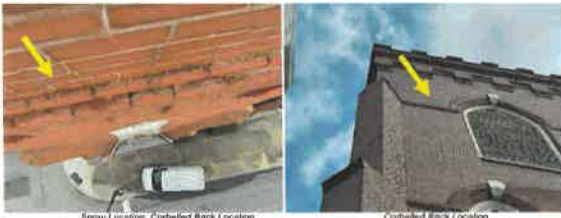
It is worth noting that the leakage locations at the interior aligned closely with the corbelled brick courses installed along the wall. It is possible that these courses are capturing water that is running down the face of the wall and causing significant deterioration of the mortar at these locations. SKA noted significant deterioration at the corbelled course where the spray rack was positioned.

Spray Location, Corbelled Brick Location

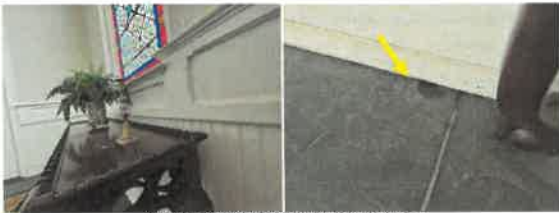
The test was planned to be run for 1.5-hours, however, after approximately 1-hour, water intrusion was noted at the tile floors at the interior of the tower in several locations. In one location, the water was running down the face of the paneling above. Other locations did not exhibit visible water on the wall. It appears that water is collecting and being stored in the mass masonry until it collects along the base of the wall.

Water Infiltration Noted at Two (2) Locations Below Window Area

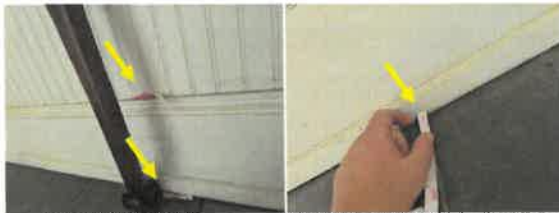
Water Infiltration along Interior of Paneling

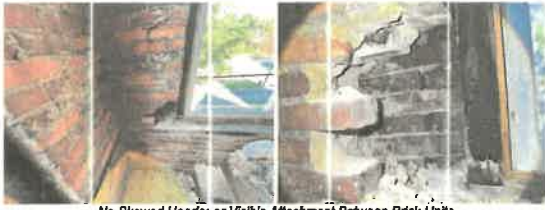
- A 1-1/4 inch gap or space is present between middle modular wythe and exterior pressed brick wythe. It appears that skewed header courses were only installed where the brick masonry wythes align (which is not often). Gap appears to be area where the exterior wythe is separating from the middle wythe.

No Skewed Header or Visible Attachment Between Brick Units

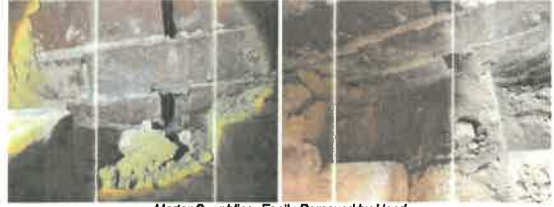
Mortar Crumbling, Easily Removed by Hand

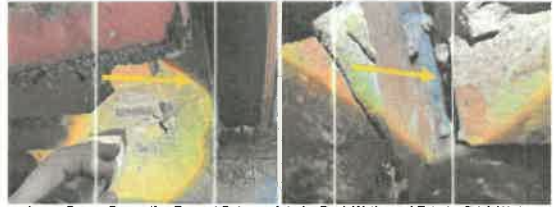
Large Gap or Separation Present Between Interior Brick Wythe and Exterior Brick Wythe

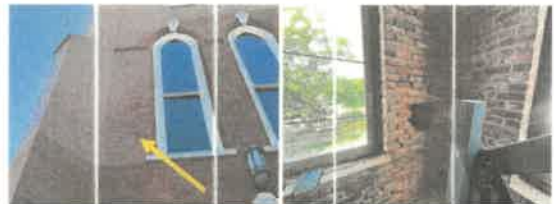
Newer Exterior Pressed Brick Location

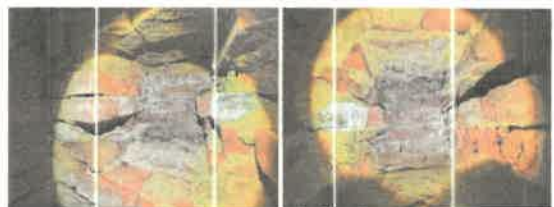
No Skewed Headers Present

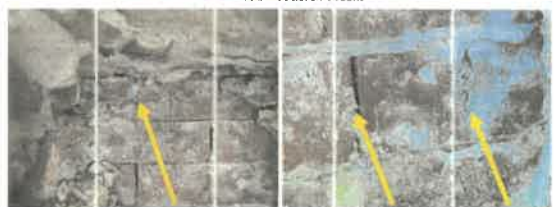
- Exterior wythe head joints were not filled solid. Mortar missing throughout. Daylight is visible at several mortar joints at multiple locations.

Daylight Visible Through Exterior Mortar

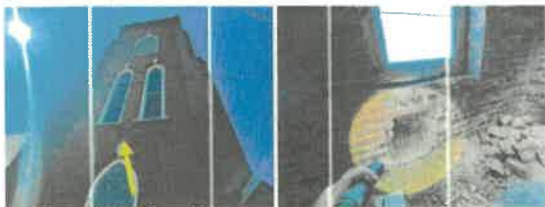
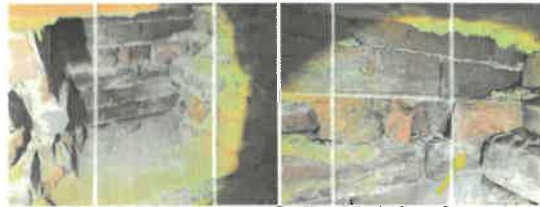
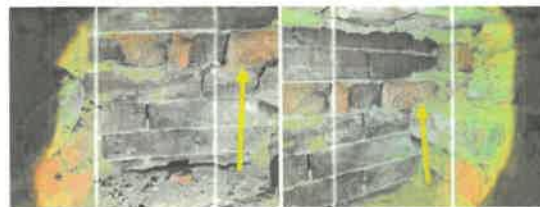
- A majority of the mortar at the interior wythe was noted to be missing, likely due to water infiltration.
 - Exterior wythe head joints were not filled solid. Daylight was visible through these joints at multiple locations.
