City of Goldsboro
Historic District
Commission
June 03, 2025

AGENDA
HISTORIC DISTRICT COMMISSION
City of Goldsboro
Tuesday, June 03, 2025, 5:30 P.M.

Sanctuary Building Brick Masonry Investigation Report

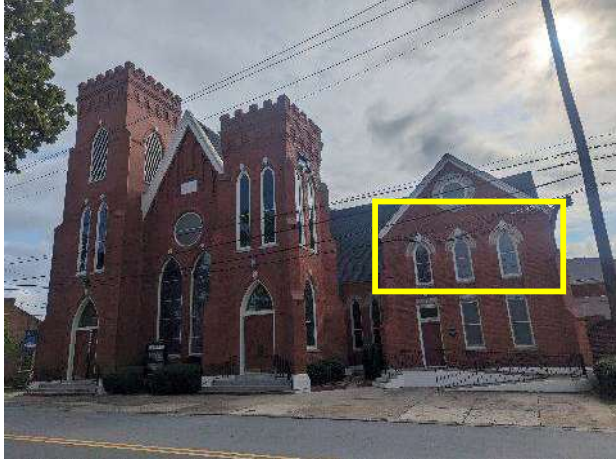
Southern Section of Building

- In the southernmost section along the west elevation of the second-floor level of the sanctuary, paint delamination at trim and plaster damage (cracks) were noted along the west elevation typically at the base of the wall under the level of the windowsills. No elevated levels of moisture were detected. Delamination and/or damage was noted at wood trim at perimeters of windows and adjacent the window heads.

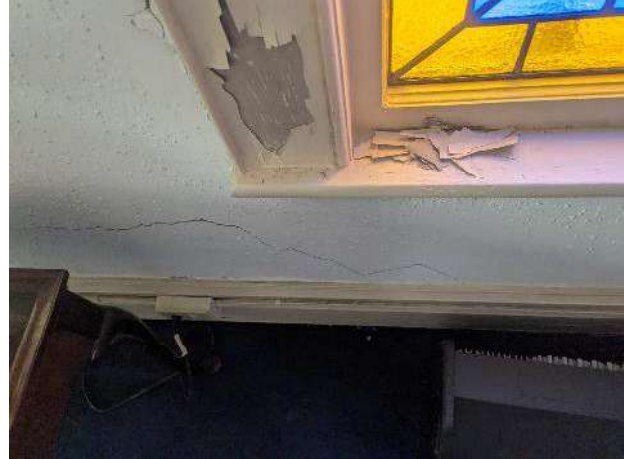
Trim Paint Delamination

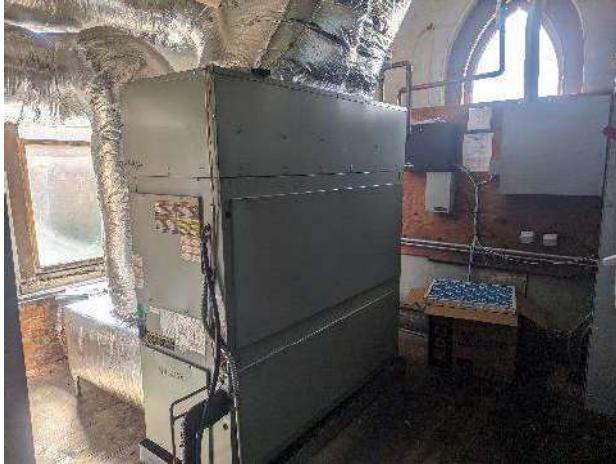
- At the east elevation second floor mechanical room, large gaps in the brick masonry are present. The gaps in the masonry appear to be old or abandoned mechanical penetrations where the brick masonry was not subsequently restored. Two (2) mechanical units located in this area appear to be more recent installations. However, penetrations through the brick masonry do not appear to be properly sealed.

Second Floor Mechanical Room

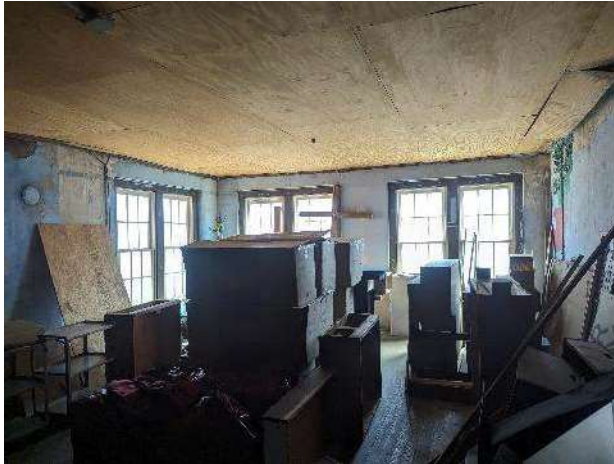
Second Floor storage room

- At the east elevation second floor storage rooms (adjacent to the mechanical room), gaps in the brick masonry are present. This is likely from mechanical components that have been removed. In addition, plaster delamination is present adjacent to these areas.

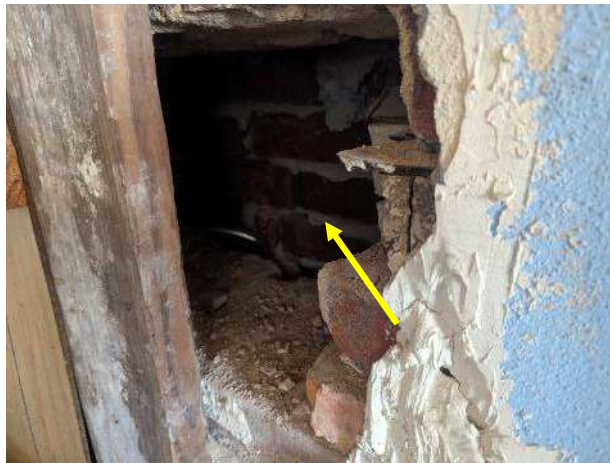
Gap in brick masonry

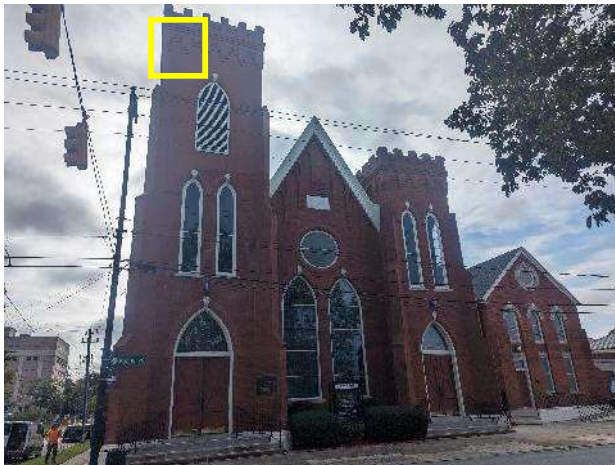
Water Test #01 Location

Two (2) locations were selected to be tested. The first location was selected to be the taller, northwest tower. Water was applied to the western face near the north corner of the tower just below the battlement parapet. The second location was at the shorter, southwest tower. Water was applied to the south elevation just below the sill of the second floor windows.

The ASTM E1105 spray rack was positioned approximately 4-foot below the top of the battlement at the northern corner of the western elevation. This location was selected as severe water damage was visible at the plaster installed along the interior of the bottom floor of the tower. This damage extended along the entirety of the north elevation and ½ of the east and west elevations from the ceiling (approximately 15-foot high) to the transition to paneling (approximately 4-foot high).

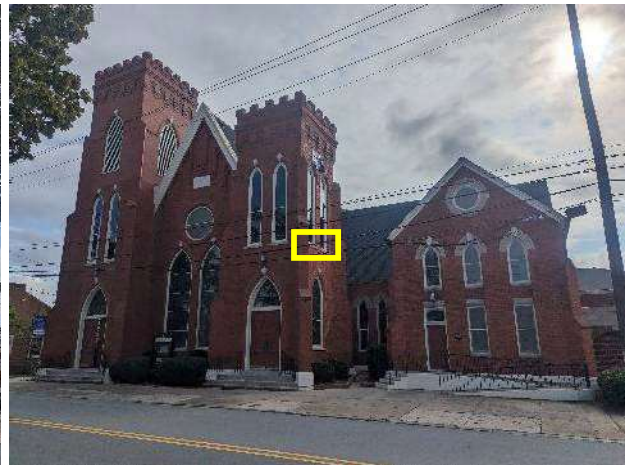
Water Test #02 Location

The ASTM E1105 spray rack was positioned just below the second floor window along the south elevation of the southwest tower. This location was selected as minor water damage was visible at the plaster installed along the interior of the bottom floor of the tower.

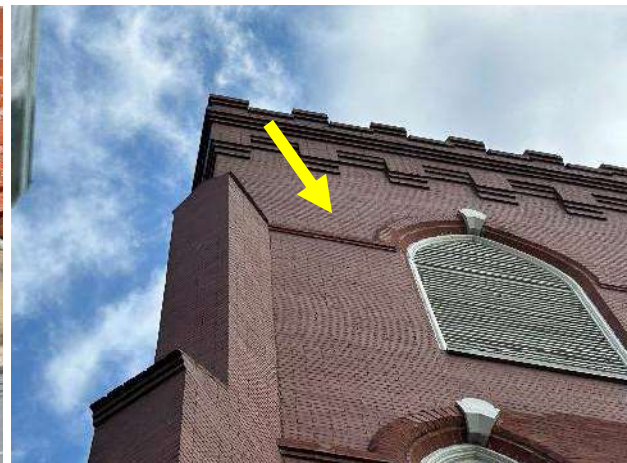
It is worth noting that the leakage locations at the interior aligned closely with the corbelled brick courses installed along the wall. It is possible that these courses are capturing water that is running down the face of the wall and causing significant deterioration of the mortar at these locations. SKA noted significant deterioration at the corbelled course where the spray rack was positioned.

Corbelled Brick Location

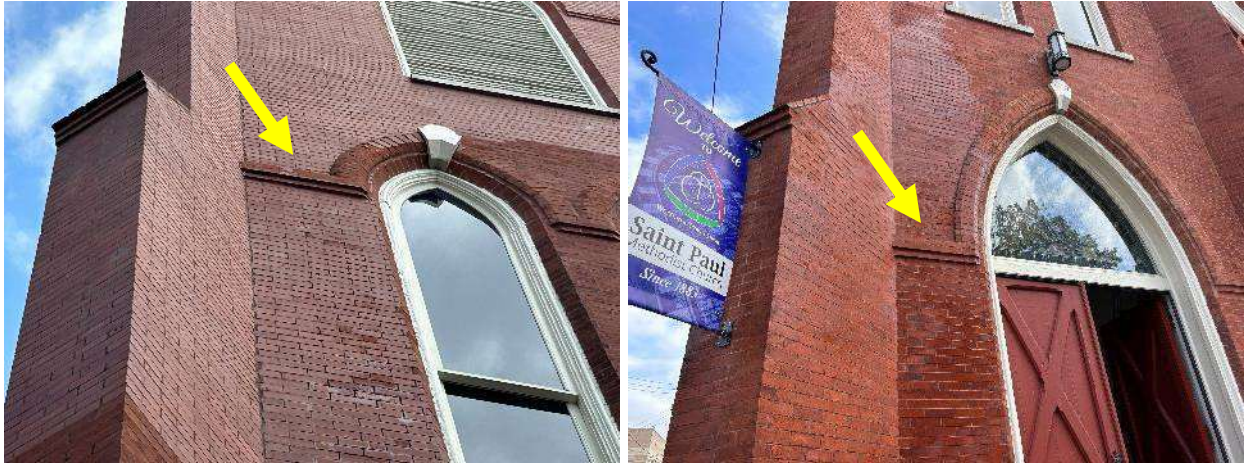
Corbelled Brick Location

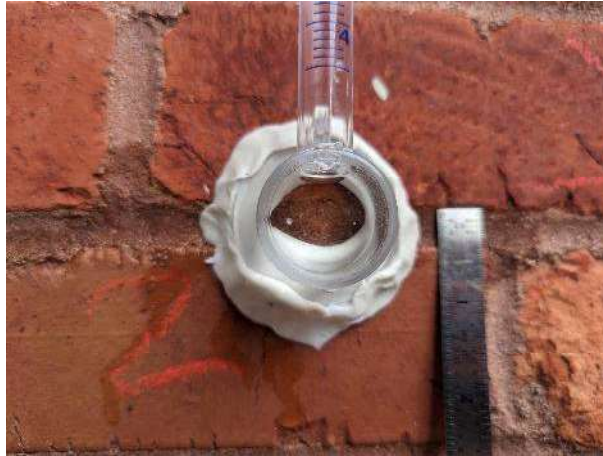
Rilem Test Tube – Bed Joint: Wetting / Absorption of Mortar during Testing

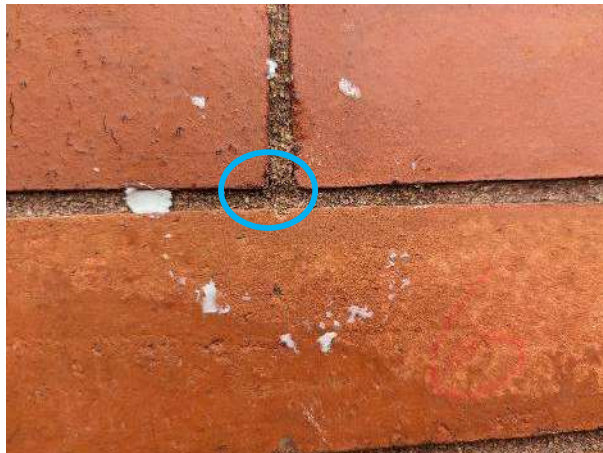
- The bottom of head joints usually allows the highest water penetration rates followed by the middle of the head joint, bed joints and top of head joints.
- Joints that absorb 5 ml of water in 5 minutes or less are most likely to leak water through a wall. Joints requiring 15 minutes or more to absorb 5 ml of water show no signs of leakage as wetting patterns on the back of the wall. Five (5) tests resulted in leakage requiring less than 15-minutes to absorb approximately 5 ml of water with three (3) of these tests exhibiting leakage in less than five (5) minutes.

Rilem Test Tube – Test #6 – 4.5ml Absorbed in Less than 1-Minute with Small Void in Mortar Visible.

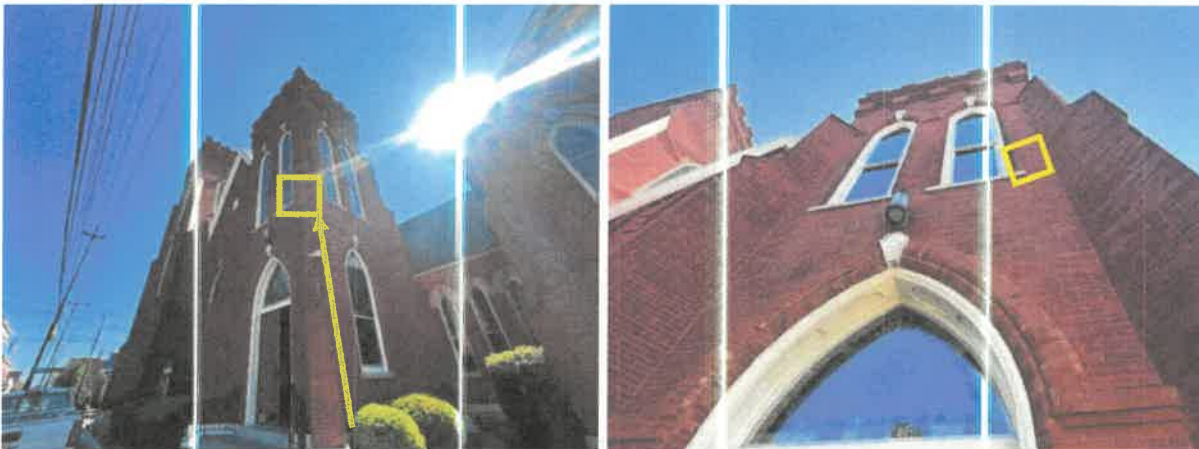
Excavation #01 - Approximate Location at Interior Excavation of South Tower

- Mortar Condition: **Poor/Failed** – Sandy, easily removed by hand
- Additional Information
 - Interior clay brick masonry units appear original.
 - Brick units at interior two (2) wythes appear to be modular brick size, while exterior wythe is pressed brick, which is standard size or larger.

- Neither header nor skewed header courses were observed at: the five (5) courses of brick removed or the single courses above and below excavation, seven (7) courses with no visible attachment to exterior pressed brick.

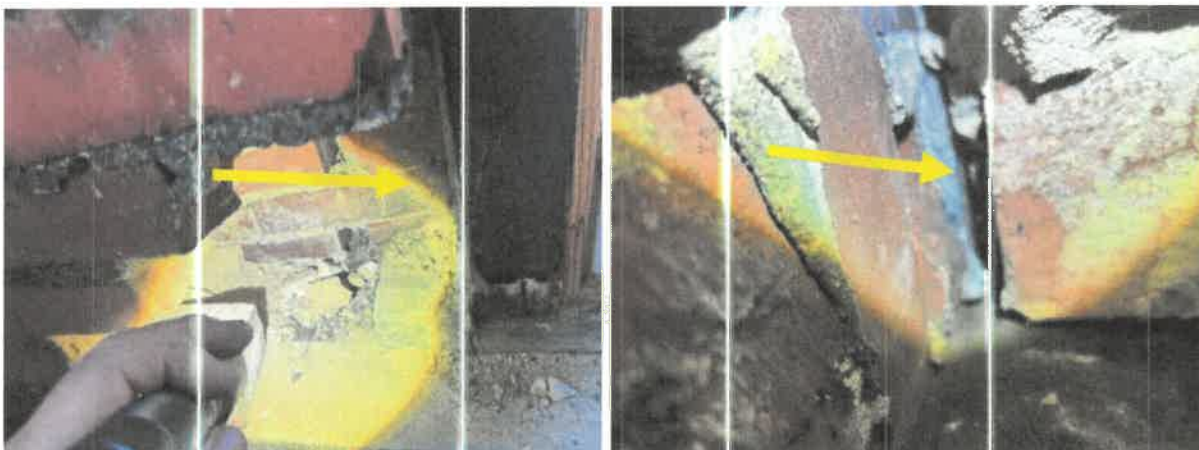
Large Gap or Separation Present Between Interior Brick Wythe and Exterior Brick Wythe

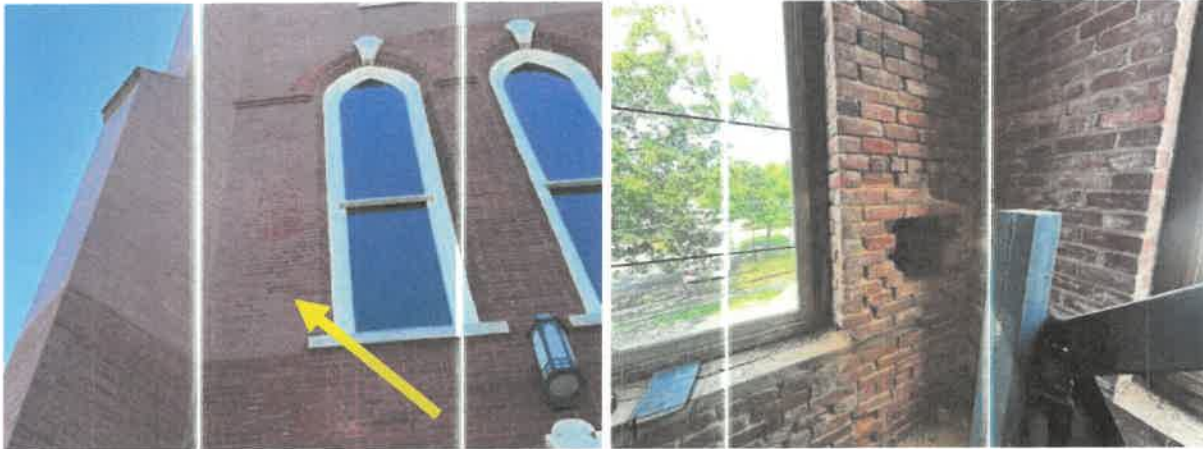
- Additional Information:
 - Existing interior brick masonry units appear original. Pressed brick masonry units along the exterior appear to have been replaced, likely after Hurricane Hazel.

Newer Exterior Pressed Brick Location

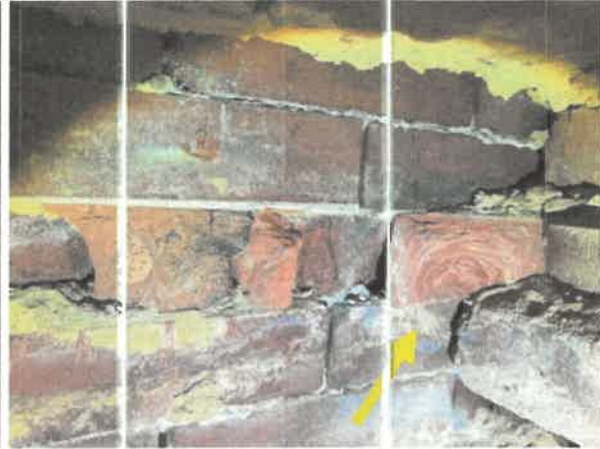
- Mortar Condition: **Poor/Failed** – Washed out, sandy, easily removed, missing at interior wythe
- Additional Information:
 - All existing brick units appear original at this location.

- A majority of the mortar at the interior wythe was noted to be missing, likely due to water infiltration.
 - Exterior wythe head joints were not filled solid. Daylight was visible through these joints at multiple locations.

Skewed Header Course Discovered

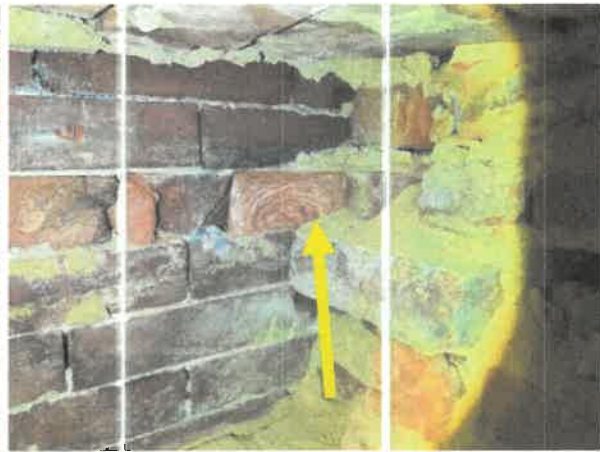
Skewed Header Course Discovered
