MINUTES OF THE MEETING OF THE
GOLDSBORO HISTORIC DISTRICT COMMISSION
JUNE 3, 2025

Sanctuary Building Brick Masonry Investigation Report

Saint Paul Methodist Church
204 East Chestnut Street
Goldensboro, North Carolina 27530

SKA Project No. 230217.0

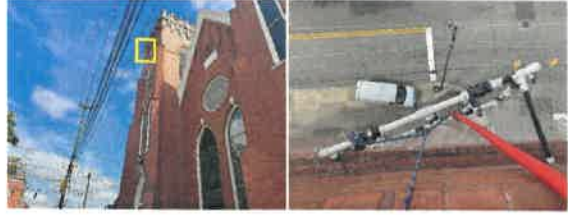
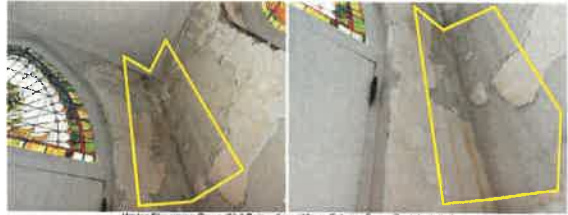
Water Test #01 (WT#01) – Northwest Tower, West Elevation

The ASTM E1105 spray rack was positioned approximately 4-foot below the top of the battlement at the northern corner of the western elevation. This location was selected as severe water damage was visible at the plaster installed along the interior of the bottom floor of the tower. This damage extended along the entirety of the north elevation and ¼ of the east and west elevations from the ceiling (approximately 15-foot high) to the transition to paneling (approximately 4-foot high).

Initially, the testing was intended to be run for 1.5-hours, however, when SKA checked the interior for 45-minutes, water was streaming down the wall in numerous locations. Testing was concluded at this point. Water intrusion was noted to be coming from the following locations:

- Streaming down the wall in the room with the damaged plaster. The water appeared to be coming from above the ceiling, however, it is also possible that the water was intruding through the windows in addition.

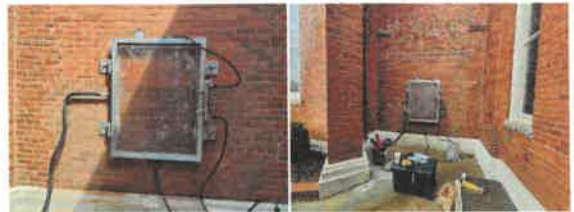
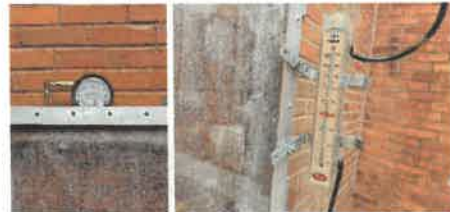
Water Test #03 - ASTM C1601

- Pre-condition the wall surface for 30 minutes prior to beginning the measurements.
- Apply water at a rate of 3.4 gal/m²/h times the area of the wall being tested (12 square feet). A positive, sustained air pressure of 10 psf (1.92 inches of water column) is created in the chamber to simulate a wind-driven rain event.

- Run the test for 4 hours and record water penetration rates at 5-minute increments.

This standard test method represents a rain event equal to approximately 5-1/2 inches of water per hour accompanied by an estimated 62.5 mph wind speed. These test conditions are severe and probably represent conditions that might normally be expected to occur during severe rain events. It is likely that this type of condition may happen no more than one or two times during the life of a building.

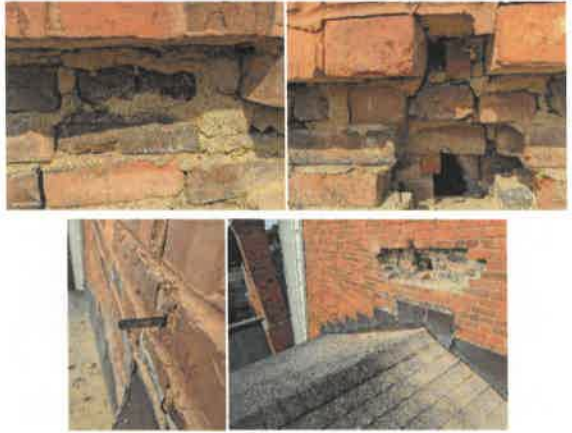
Field Excavation TC-2

Size = ~24" W x 13" to 13-1/2" D x 16" H (6 brick courses high)
 Cladding = Brick Masonry Units ~ 7-3/4" L x 3-5/8" D x 2-1/4" H
 Cladding Attachment = Brick mortar (Possible Sand and Lime or Type 'O')
 Cladding Thickness = 3 Width Multi-Wythe Wall
 Brick Joint Width (Bed) = ~1/4" to 3/8"
 Brick Joint Width (Head) = ~1/4" to 3/8"
 First Cavity Width = ~ 1" to 1-1/4"
 Second Cavity Width = ~ 1/8" to 3/8"
 Third Cavity Width = N/A
 Substrate = Brick
 Mortar Condition = **Fair to Poor**: Can be broken by hand and scraped with steel awl
 Substrate Thickness = 13" to 13-1/2"
 Other Information = Roof Angle ~ 23°-25°: Approximately 5/12 Slope or Pitch.
 Brick units appear to be newer.
 Copper Step - and Counter – Flashing Weight: ~ 16 oz./ft²
 Copper Step Flashing: ~8" L x 8" W
 [4" V Leg (outside of brick x 4" H Leg (under shingle tab))
 Wooden slats (~5" to 5-1/2" from back of brick to back of wood)
 Insulation (white, fluffy) visible in Attic: Possibly Fiberglass

Exterior S/H Course second course below opening.
 Exterior S/H Course just above opening.
 Spacing to next S/H Course = 8 Horizontal Brick Courses
 Interior S/H Course installed just below upper Exterior S/H Course
 Opening begins 23" above end of roof rake,

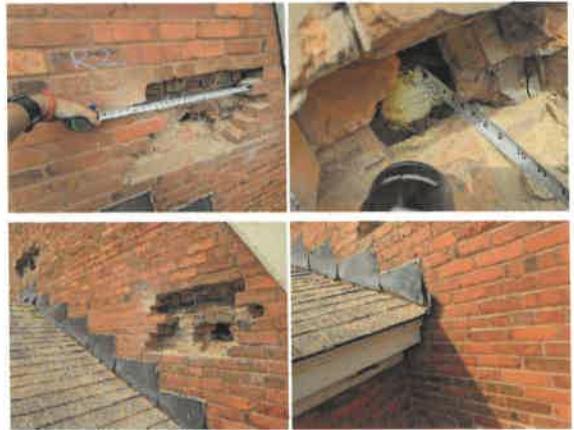
Field Excavation TC-3

Size = ~20-1/4" W x 22" H (6 brick courses high)
 Cladding = Brick Masonry Units ~ 7-3/4" L x 2-1/4" D x 2-1/4" H
 Cladding Attachment = Brick mortar (Possible Sand and Lime or Type 'O')
 Cladding Thickness N/A
 Brick Joint Width (Bed) = N/A
 Brick Joint Width (Head) = N/A
 First Cavity Width = N/A
 Second Cavity Width = N/A
 Third Cavity Width = N/A
 Substrate = Brick

Mortar Condition = **Poor**: Can be broken by hand and scraped with steel awl
 Substrate Thickness = 13-1/2" at buttress
 Other Information = Cap Angle ~ 43° - 45°; Approximately 17-1/2" x 13-1/2"
 Brick units appear to be original.
 Visible gap (~ 5" to 6" deep) along bottom of angle masonry top
 (filled with mortar)

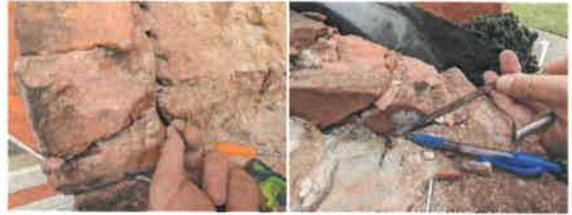
Field Excavation TC-04

Size = ~20-1/2" to 21-1/4" W x 13-1/2" D x 25-1/2" H (10 brick courses high)
 Cladding = Brick Masonry Units ~ 8-3/8" L x 4-1/8" D x 2-1/8" H
 Cladding Attachment = Brick mortar (Possible Sand and Lime or Type 'O')
 Cladding Thickness = **Estimated to be** 4 Width Multi-Wythe Wall
 Brick Joint Width (Bed) = ~3/16" to 1/4"
 Brick Joint Width (Head) = ~3/16" to 1/4"
 First Cavity Width = ~1/4" to 1/2"
 Second Cavity Width = ~1/4"
 Third Cavity Width = ~1/4"
 Substrate = Brick

Mortar Condition = **Poor**: Can be broken by hand and scraped with steel awl
 Substrate Thickness = **Estimated to be** ~18" to 19"

Other Information = Brick units appear to be original
 ~8" (2 courses) from window keystone (at head) to bottom of opening.
 Possible exterior S/H Course first course above keystone
 Additional S/H Courses not visible along exterior brick masonry
 Spacing to interior S/H Course = 8 Horizontal Brick Courses
 Opening begins 23" above end of roof rake.

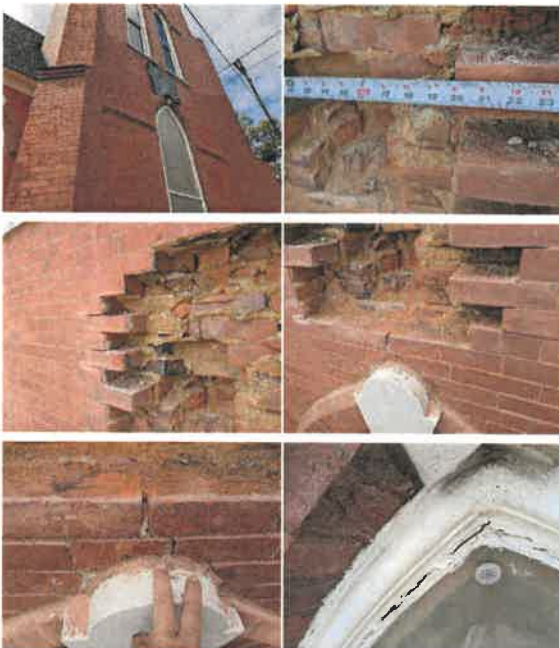
Field Excavation TC-05

Size = ~32" W x 13" to 13-1/2" D x 13-1/2" H (5 brick courses high)
 Cladding = Brick Masonry Units ~ 7-5/8" L x 3-5/8" D x 2-1/4" H

Mortar Condition = **Fair to Poor**: Can be broken by hand and scraped with steel awl
 Substrate Thickness = 12-3/4" to 13"

Other Information = Brick units appear to be newer
 Wood stud/column
 Exterior S/H Course second course below opening.
 Exterior S/H Course 3 courses above opening
 Spacing to next S/H Course = 8 Horizontal Brick Courses
 Interior S/H Course difficult to identify.
 Opening begins 2-1/2' to 3' above keystone.
