City of Goldsboro
Historic District
Commission
June 03, 2025

AGENDA
HISTORIC DISTRICT COMMISSION
City of Goldsboro
Tuesday, June 03, 2025, 5:30 P.M.

Sanctuary Building Brick Masonry Investigation Report

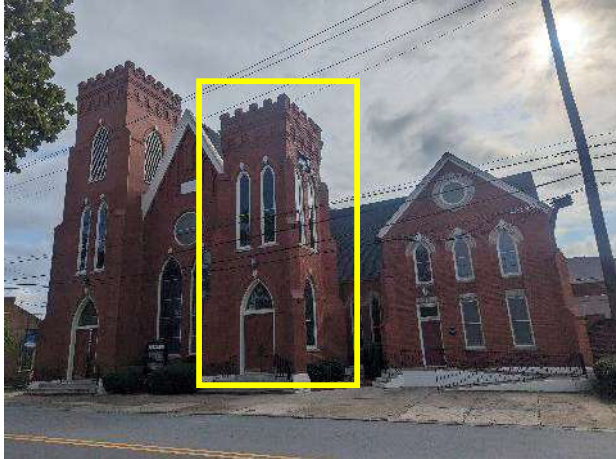
Southwest Tower

- In the shorter tower along the southwest corner of the sanctuary, minor paint and plaster damage were noted along the south and east elevation at the first floor. Moisture readings of the plaster were performed with a scan-type moisture meter: readings from 27.4% to over-limit (“OL”) were detected indicating that portions of the paint and plaster retain elevated levels of moisture content.

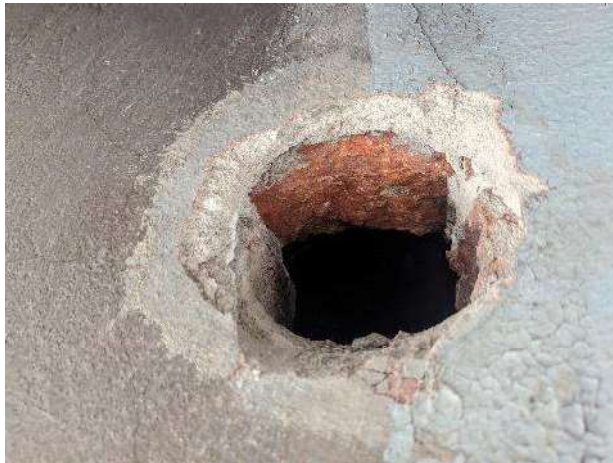
- At the east elevation second floor mechanical room, large gaps in the brick masonry are present. The gaps in the masonry appear to be old or abandoned mechanical penetrations where the brick masonry was not subsequently restored. Two (2) mechanical units located in this area appear to be more recent installations. However, penetrations through the brick masonry do not appear to be properly sealed.

Abandoned Penetrations of Brick Masonry Wall

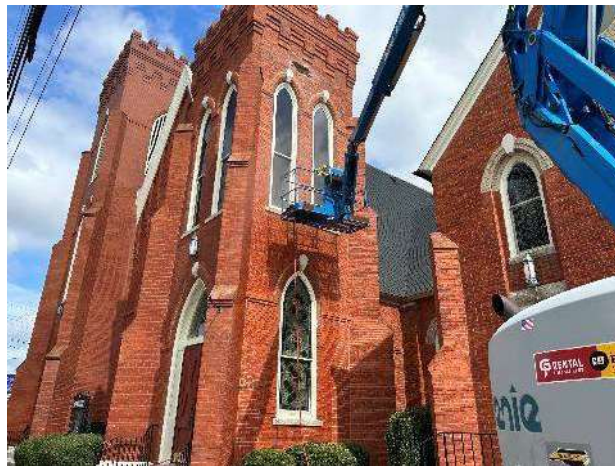
The ASTM E1105 spray rack was positioned just below the second floor window along the south elevation of the southwest tower. This location was selected as minor water damage was visible at the plaster installed along the interior of the bottom floor of the tower.

The test was planned to be run for 1.5-hours, however, after approximately 1-hour, water intrusion was noted at the tile floors at the interior of the tower in several locations. In one location, the water was running down the face of the paneling above. Other locations did not exhibit visible water on the wall. It appears that water is collecting and being stored in the mass masonry until it collects along the base of the wall.

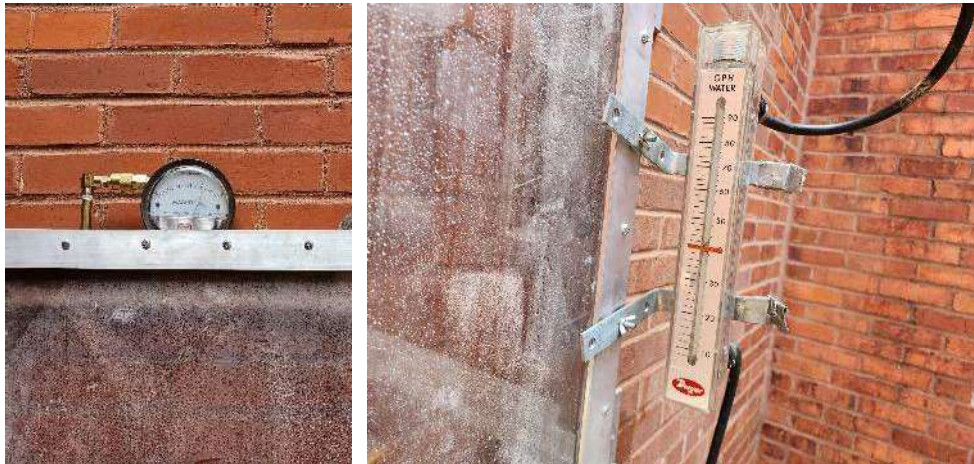
Water Test #03 - ASTM C1601

2. Pre-condition the wall surface for 30 minutes prior to beginning the measurements.
3. Apply water at a rate of 3.4 gal/ft²/h times the area of the wall being tested (12 square feet). A positive, sustained air pressure of 10 psf (1.92 inches of water column) is created in the chamber to simulate a wind-driven rain event.

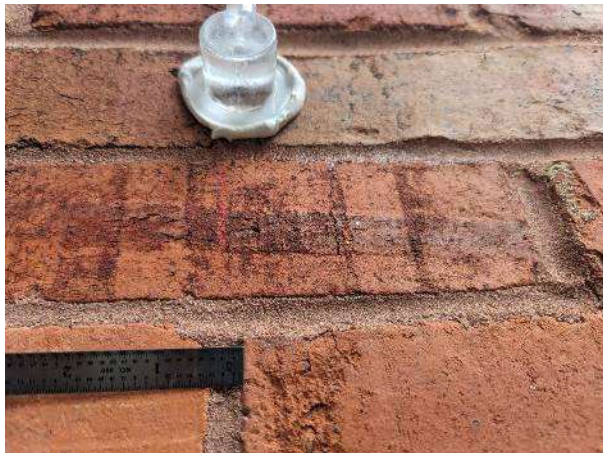
Rilem Test Tube – Head Joint

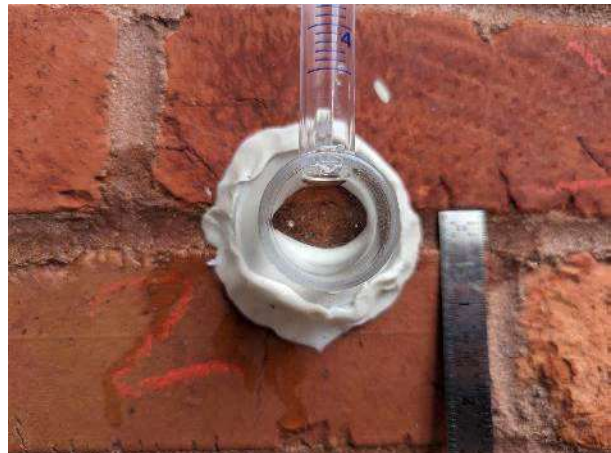
Rilem Test Tube – Bed Joint: Wetting / Absorption of Mortar during Testing

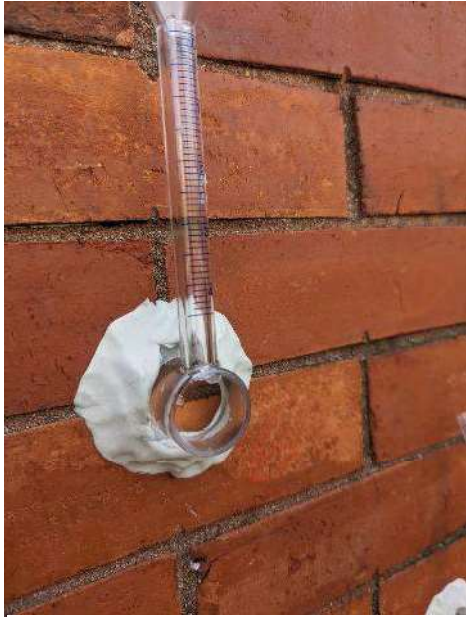
Rilem Test Tube – T-Joint

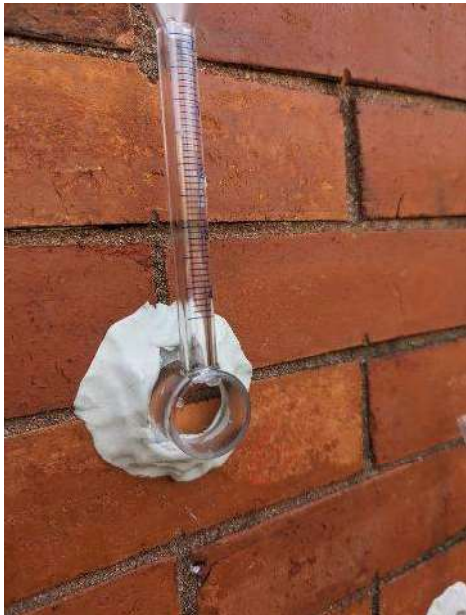
Rilem Test Tube – T-Joint Test #6

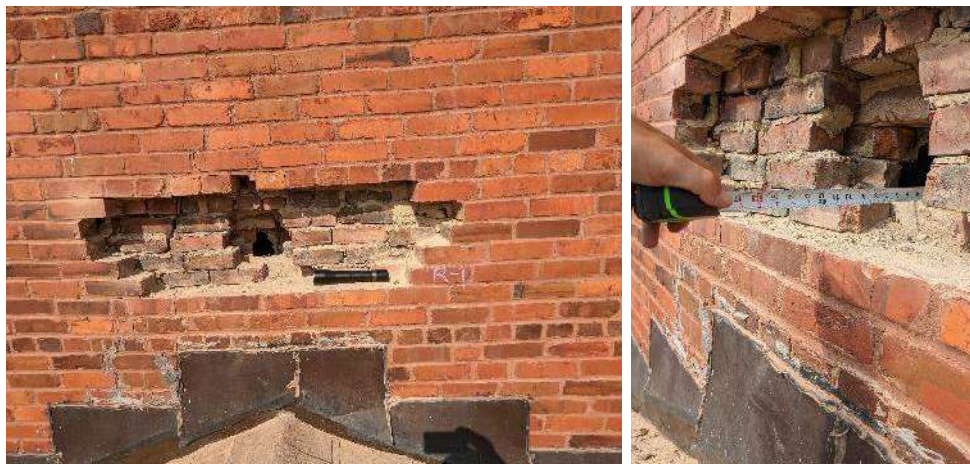
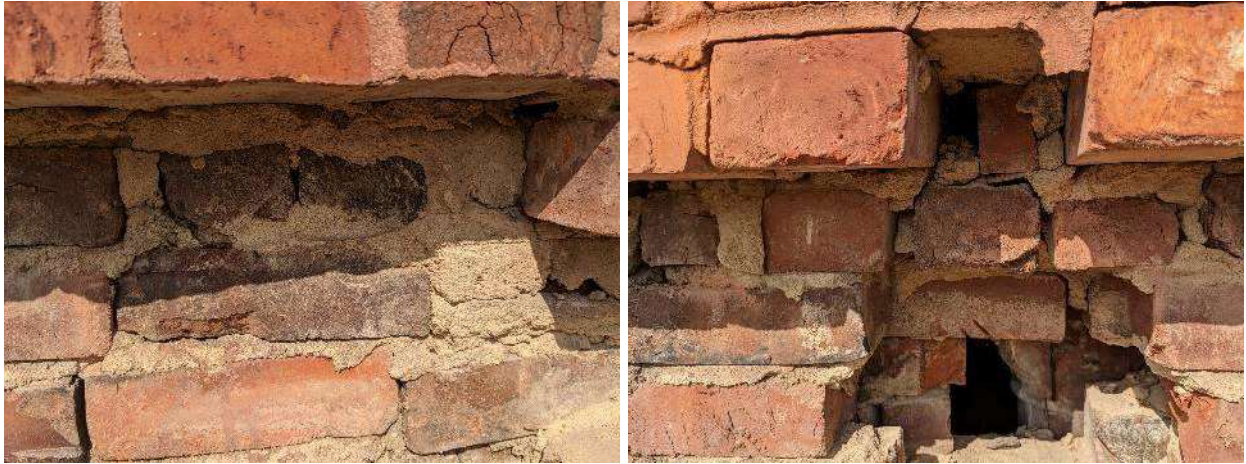
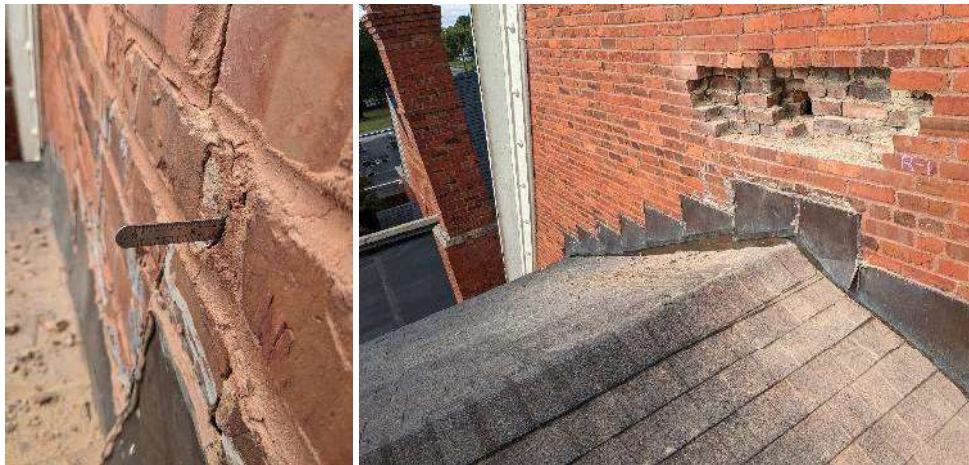
Field Excavation TC-2

Mortar Condition = **Fair** to **Poor**: Can be broken by hand and scraped with steel awl

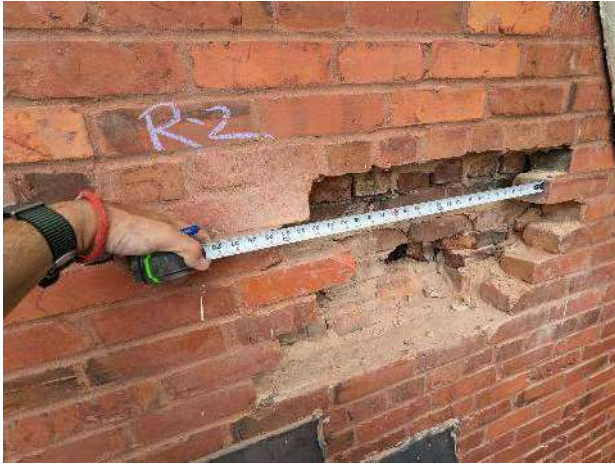
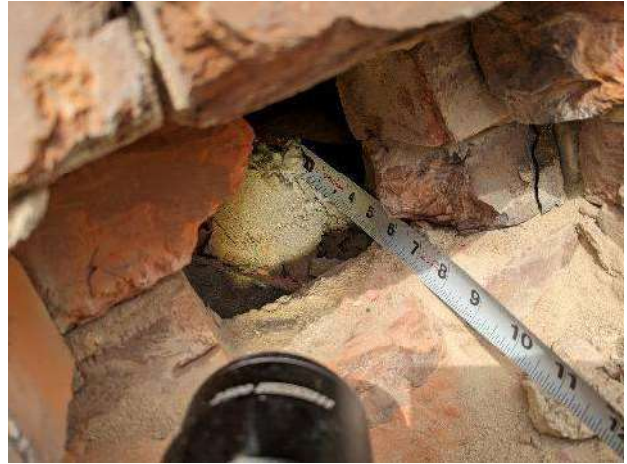
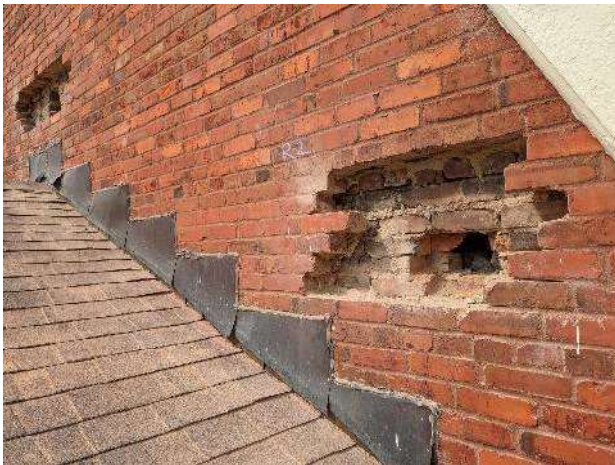
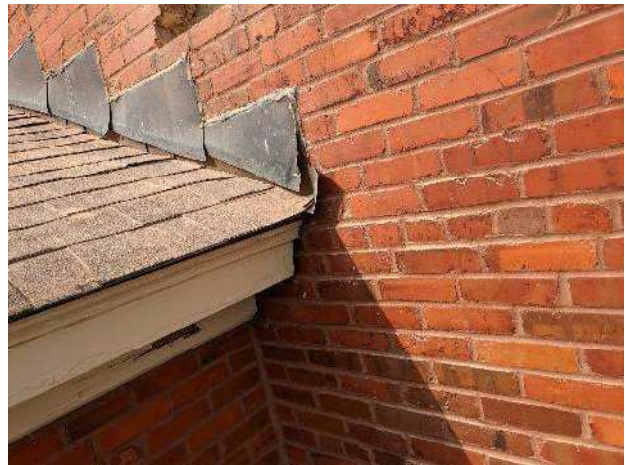
Field Excavation TC-3

Mortar Condition = **Poor**: Can be broken by hand and scraped with steel awl

Brick units appear to be original.

Visible gap (~ 5" to 6" deep) along bottom of angle masonry top
(filled with mortar)

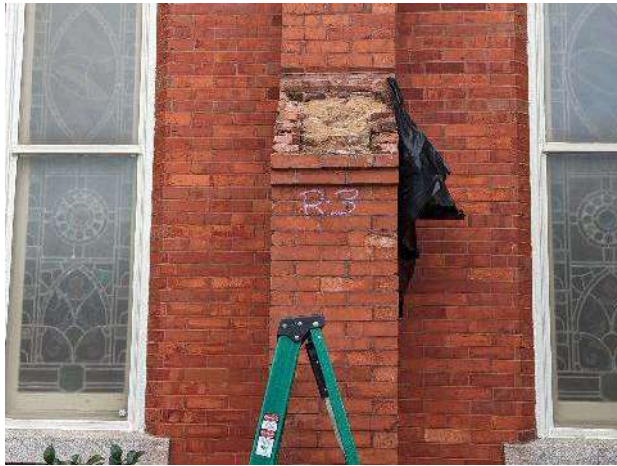
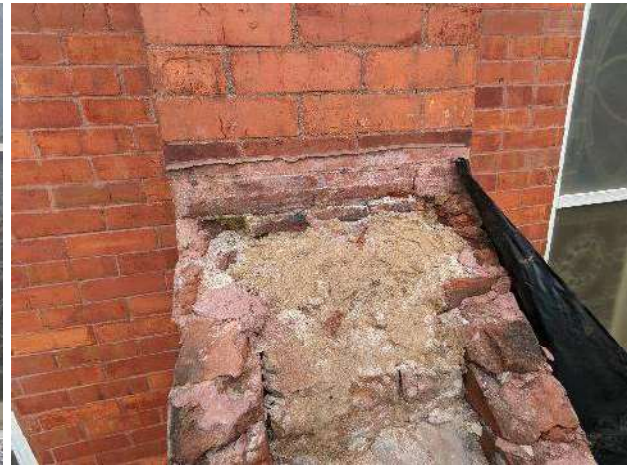
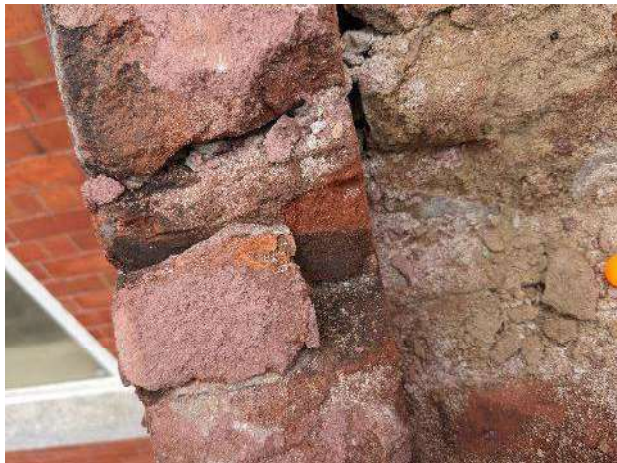
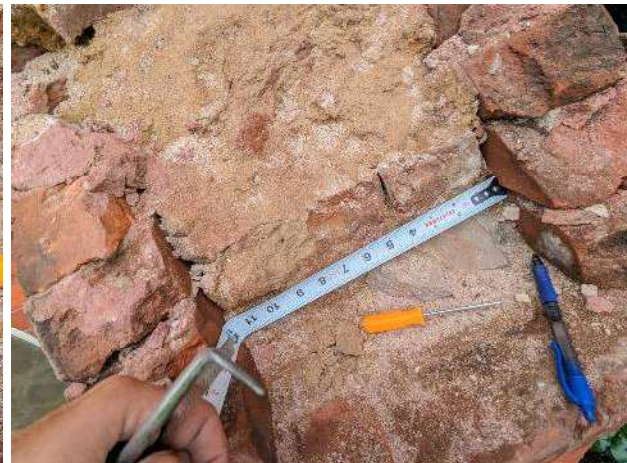
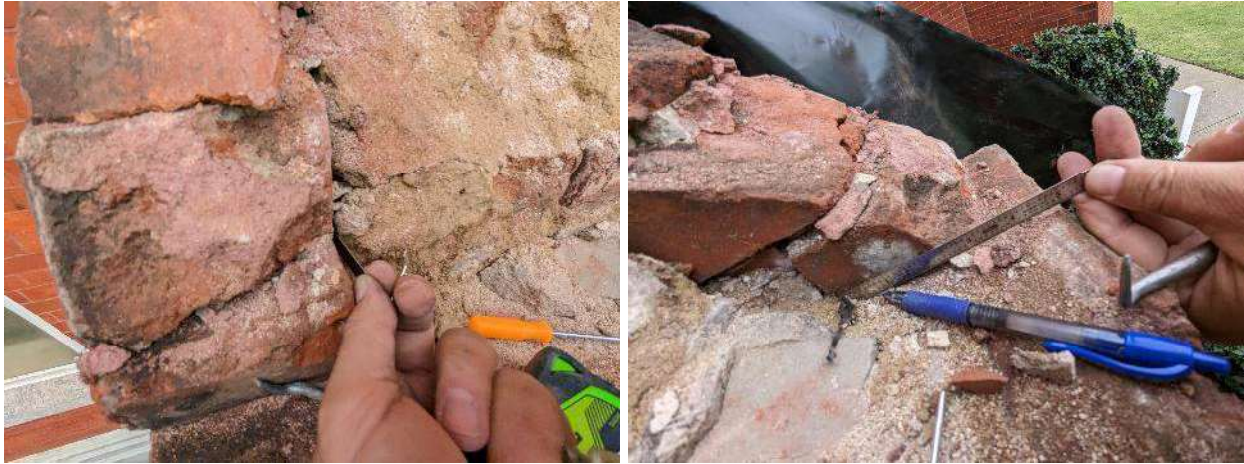
Field Excavation TC-04

Mortar Condition = **Poor**: Can be broken by hand and scraped with steel awl

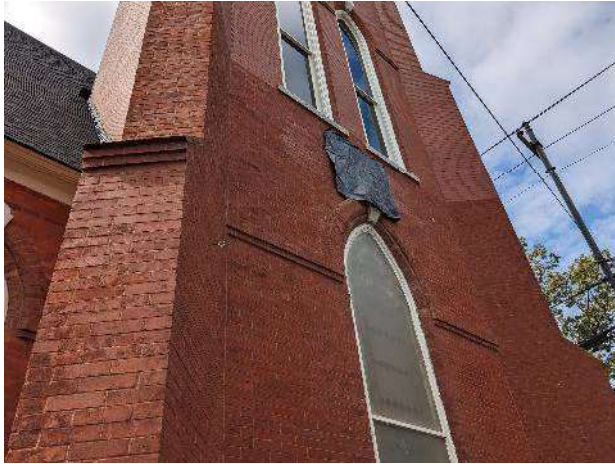
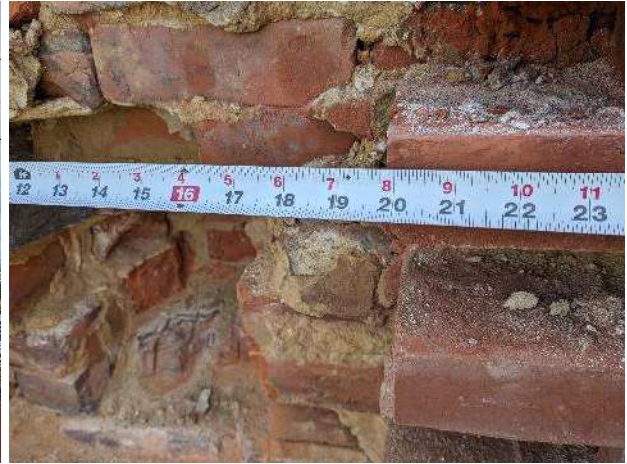
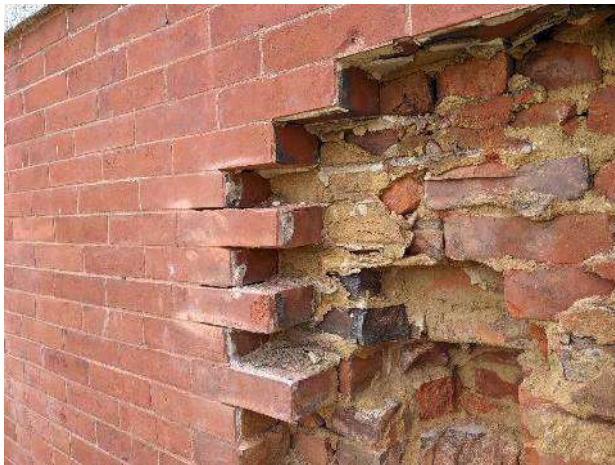
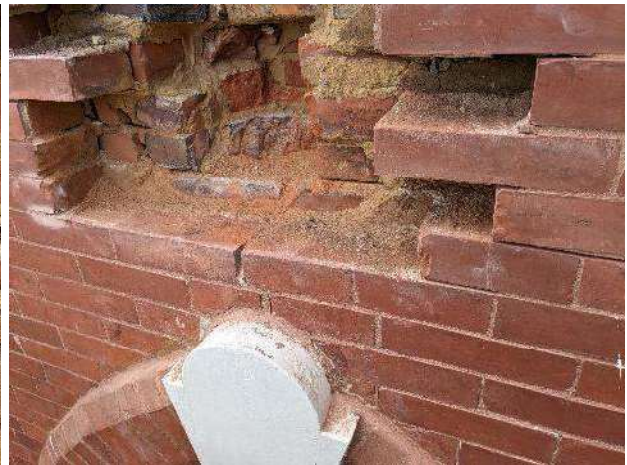
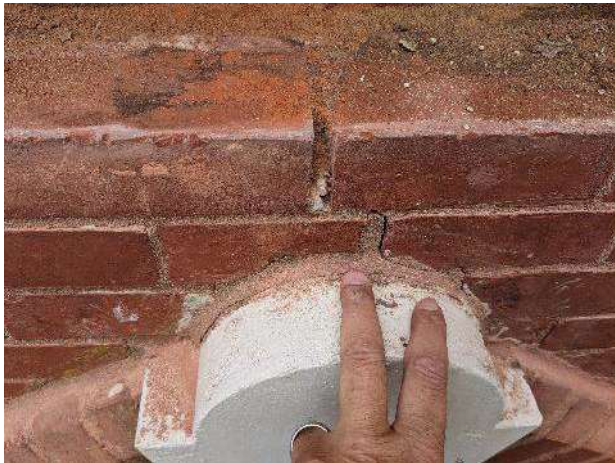
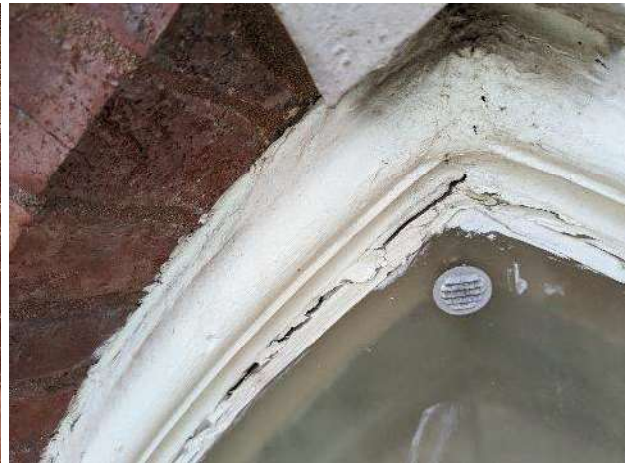
Field Excavation TC-05

Mortar Condition = **Fair** to **Poor**: Can be broken by hand and scraped with steel awl

Interior S/H Course difficult to identify.

Opening begins 2-1/2" to 3" above keystone.

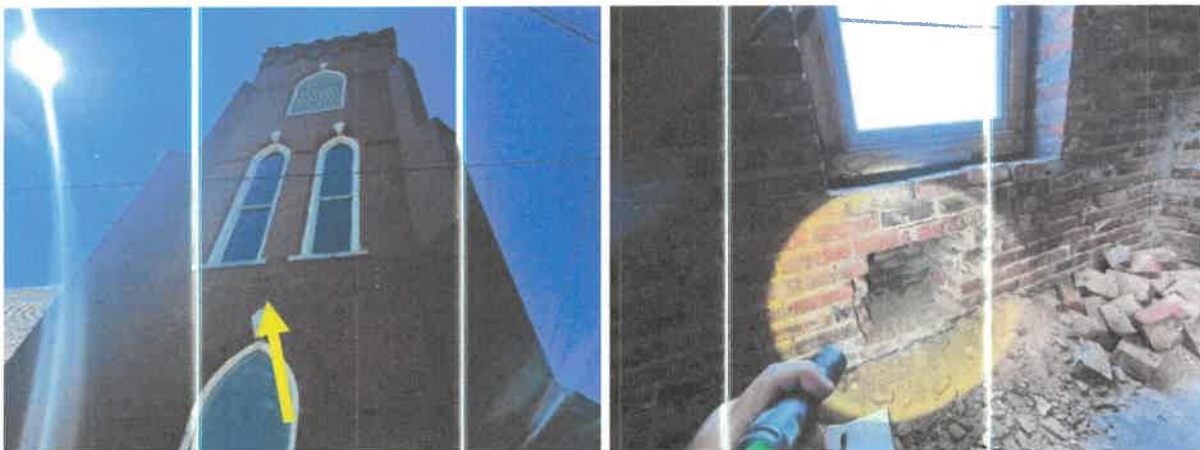
- A 1/2 inch gap or space is present between interior wythe and exterior pressed brick wythe. Separation appears smaller, likely due to skewed headers at this location remaining intact.

- A majority of the mortar at the interior wythe was noted to be missing, likely due to water infiltration.
 - Exterior wythe head joints were not filled solid. Daylight was visible through these joints at multiple locations.

Original Exterior Pressed Brick

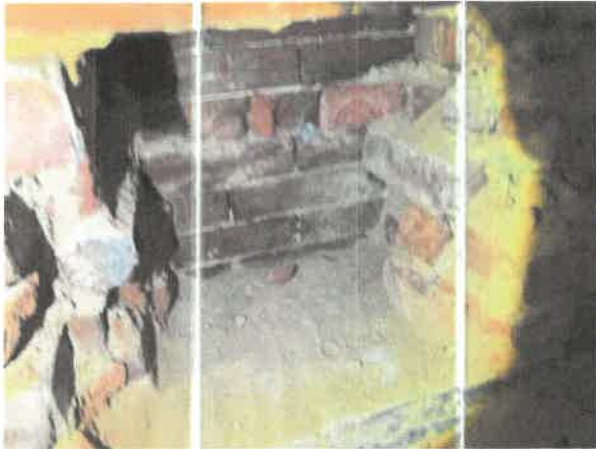
- Mortar Condition: **Poor/Failed** – Washed out, sandy, easily removed, missing at interior wythe
- Additional Information:
 - All existing brick units appear original at this location.

Mortar Sandy, Grainy

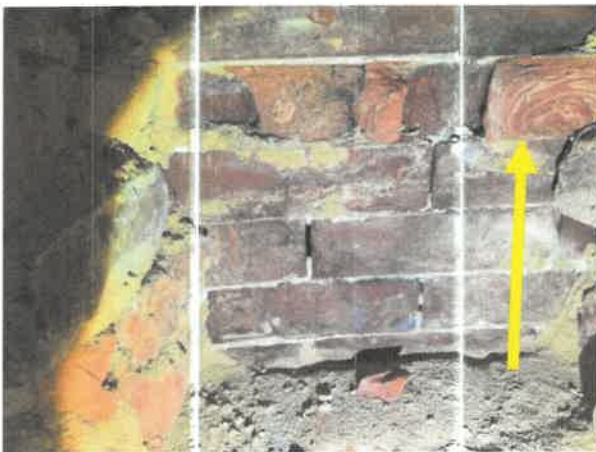
Mortar Sandy, Grainy
